November 11, 2003

**Subject: Report of Engineering Consulting Services  
United Evangelical Church - Survey of Facade Bulging Above Upper Floor  
Windows of the Original Portion of the Building  
3200 Dillon Street  
Baltimore, Maryland  
Gardner Engineering Project 956**

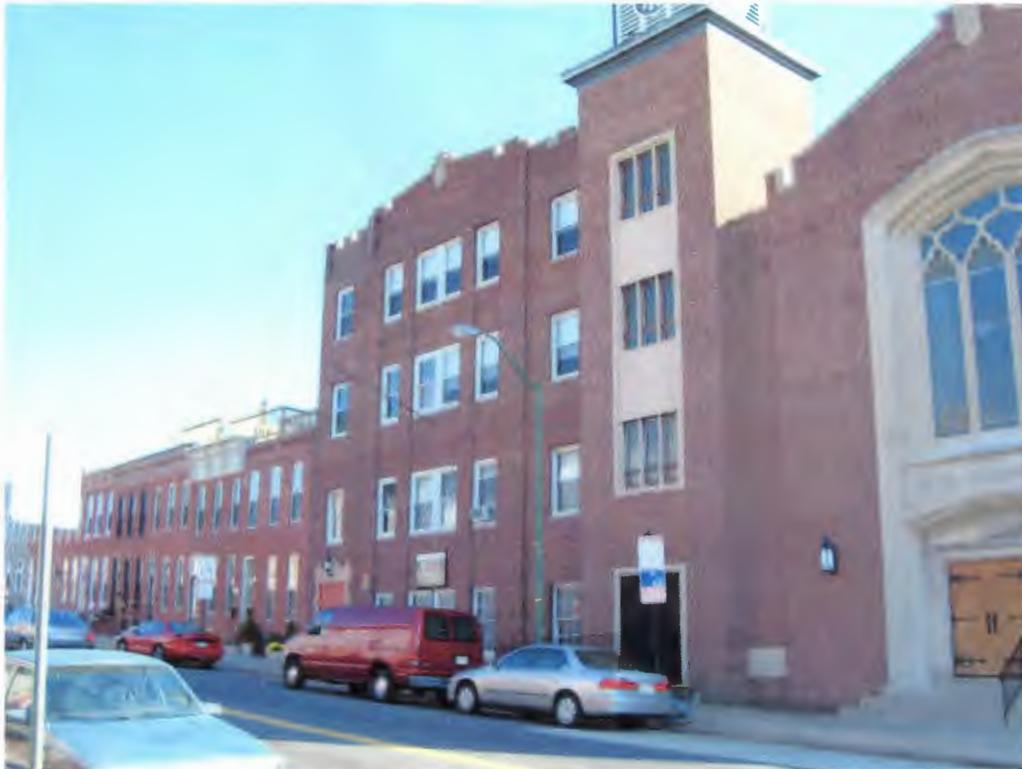
PHOTO 1 - Overview of the west elevation main entrance

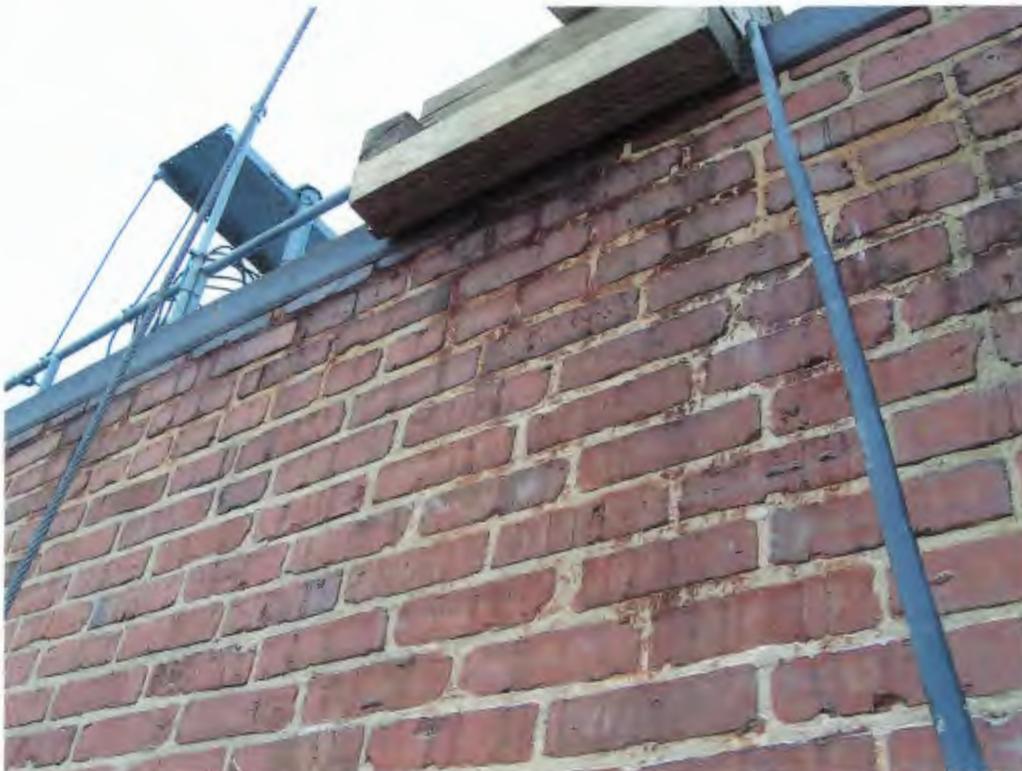
The existing metal coping on the north, south and east elevations consisted of light gauge, painted steel. The paint was observed to be peeling and flaking in many areas and the metal had begun to corrode. Corrosion staining was observed at various locations on the facade beneath the metal coping.

PHOTO 2 - Facade stains from the corroded metal roof parapet coping

2. Inspect the roof and replace deficient roof membrane and base flashings. Replace the existing metal parapet coping with a new aluminum coping
3. Remove brick above windows with distressed exterior steel lintels as necessary to remove the lintel. Inspect the central steel lintel (if any) for signs of deterioration and remove if necessary. Remove any masonry associated with removal of the central lintel. Inspect the interior steel lintel (if any) for signs of deterioration and remove if necessary. Remove any masonry associated with removal of the interior lintel. Removal of the interior most lintel will require that the repair Contractor enter interior space to access the lintel and make necessary repairs. Removal of lintels will also require support of the remaining façade as previously discussed. Replace existing distressed lintels with new steel lintels that are resistant to corrosion.

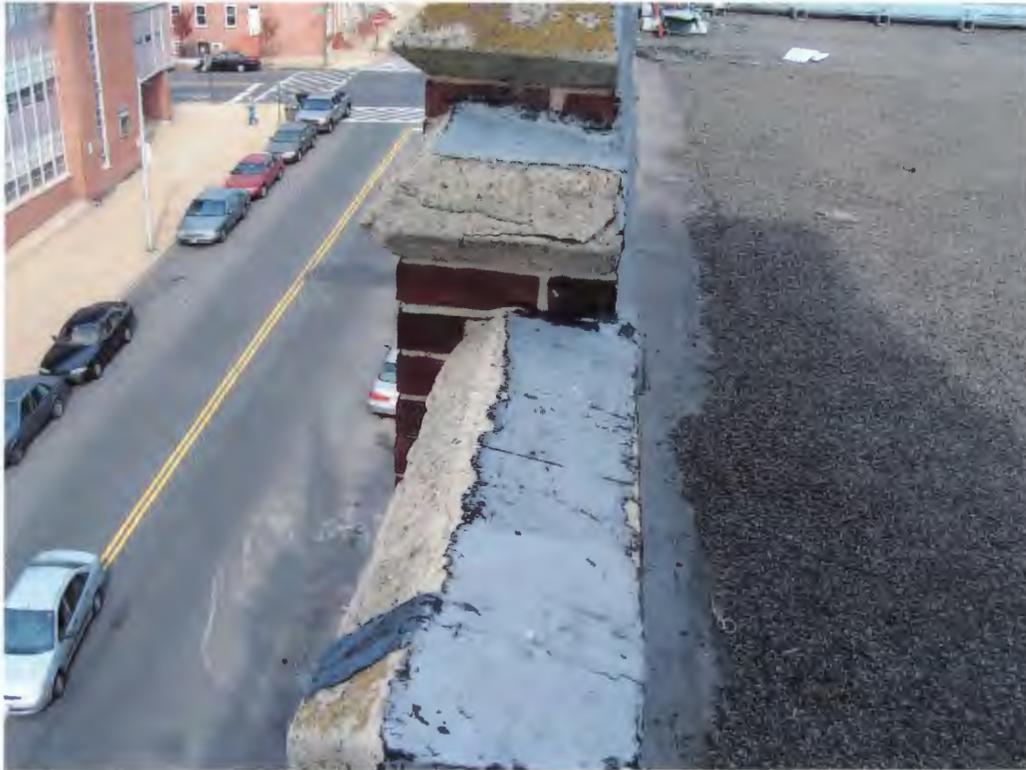
The existing decorative precast concrete coping was observed along the west and portions of the south elevations, at locations visible from the main entrance of the building. The precast concrete components had been partially covered by the new roof waterproofing membrane. Portions of the precast concrete coping that were visible showed signs of heavy erosion, spalling, and pitting. In many cases, the joints between each section of precast concrete coping had failed and were allowing water to infiltrate the masonry parapet.

PHOTO 3 - Existing cracked and spalled precast concrete coping

1. Remove the existing precast concrete coping on the west elevation and applicable portions of the south elevation. Install new precast concrete coping roof flashing, and metal counter flashing.

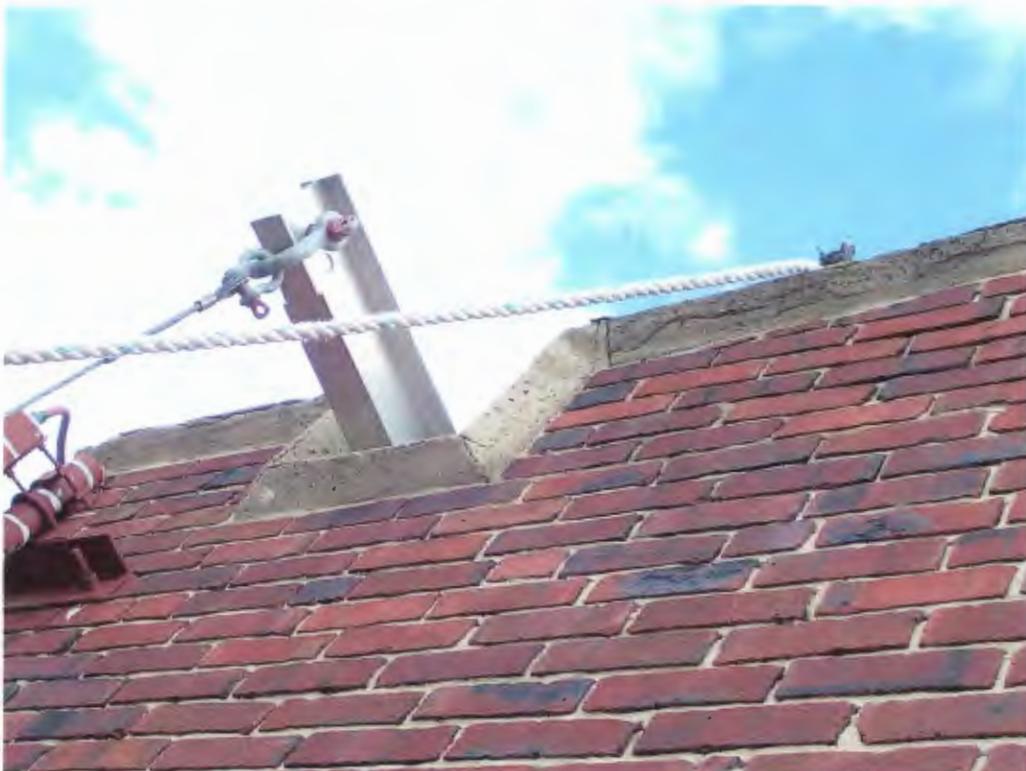
PHOTO 4 - Existing cracked and spalled precast concrete coping

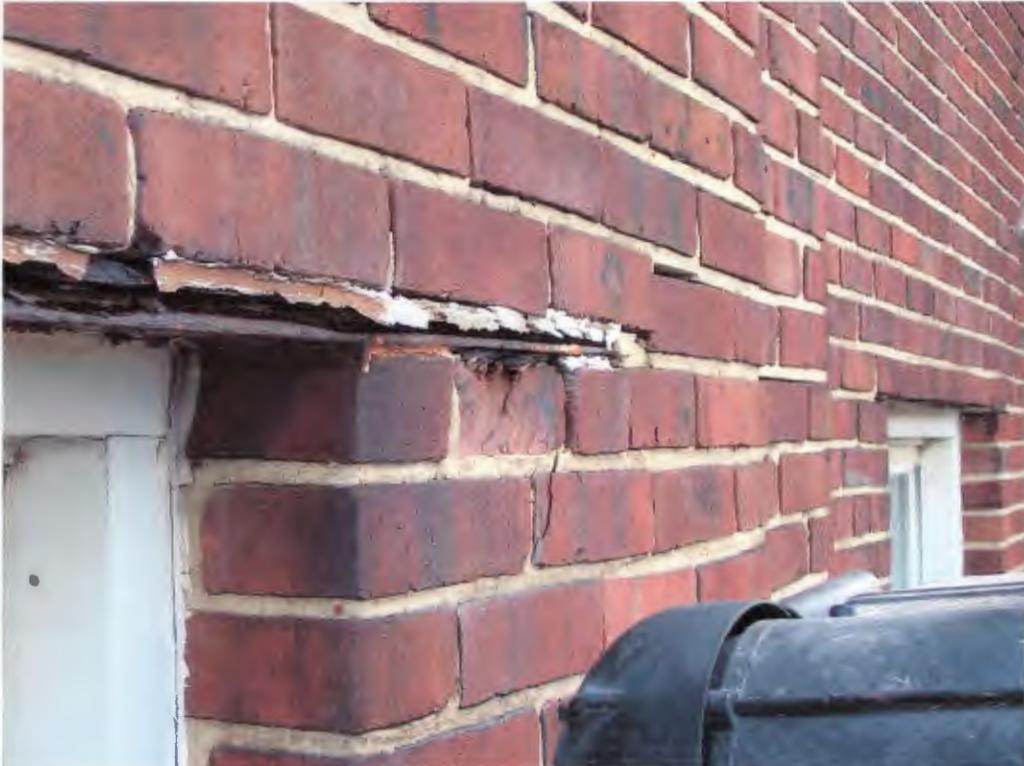
The majority of the steel lintels on the top floor and directly beneath the flat roof parapet were observed to exhibit advanced steel corrosion. We also observed lintels at lower levels that are beginning to corrode beyond a condition that might normally be considered acceptable. The expansion of the lintels has resulted in shifting, bulging, and cracking of areas of the exterior side of the roof parapet and portions of the facade in the vicinity of the corroding steel lintels. In addition, the lintels have begun to deflect significantly. This is an indication of structural yielding to the forces caused by corrosion expansion and the bearing weight of the brick masonry above the lintel. The noted deflection can cause window and door distortion, racking, and breakage.

PHOTO 5 - Example of existing lintel deterioration with associated spalled and cracked brick

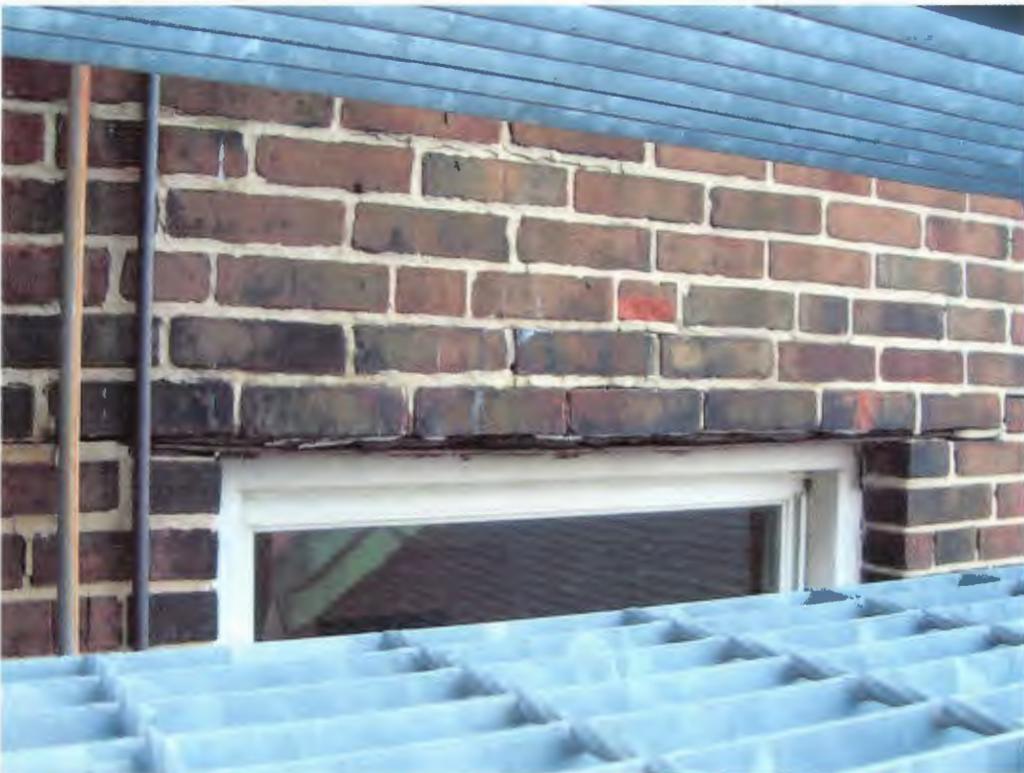
PHOTO 6 - Example of existing lintel deterioration

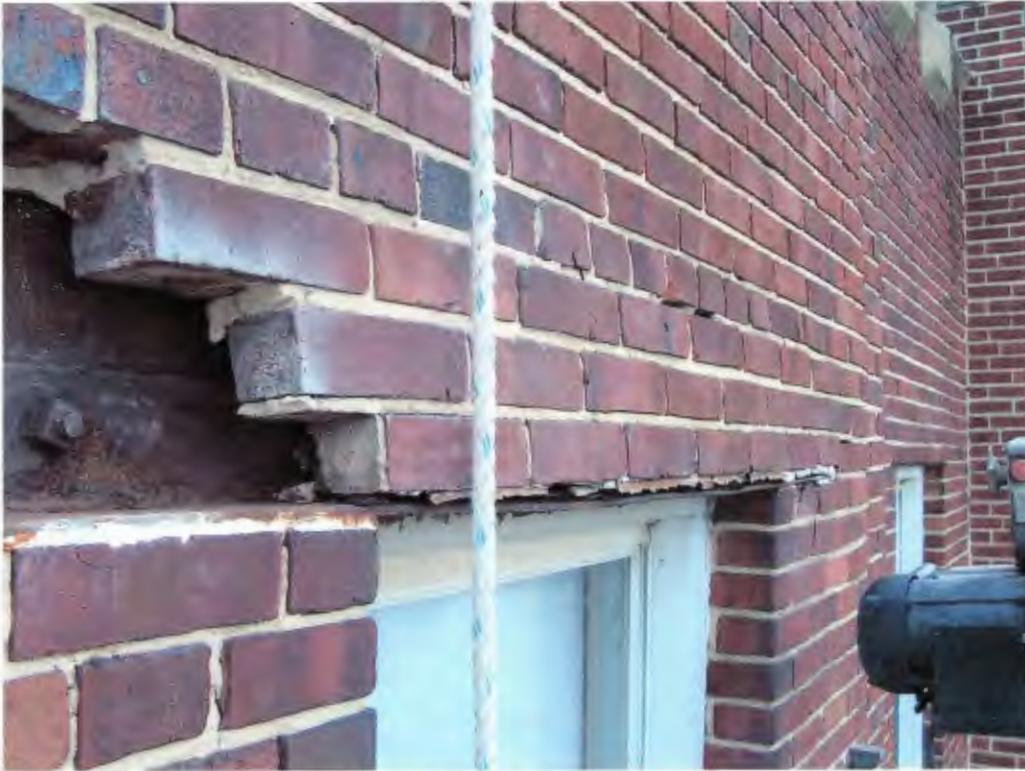
Replacement of the upper floor lintels, and replacement of other areas of advanced lintel deterioration at lower levels, will generally require that the brick masonry directly above the window lintel be removed and reset to accommodate removal of the deteriorated lintel and replacement with a new lintel. Severe cases of deterioration will require that a larger area of the exterior brick masonry facade be dismantled and reconstructed in order to bring the facade back to acceptable construction tolerances. In such cases, supplementary lateral support may also be required. During our field observations, we located three areas on the exterior of the facade, which are in need of dismantling and reconstruction. Supplementary lateral support will likely be required. These areas are as follows:

PHOTO 7 - Bulging portion of the facade above deteriorated lintel

4. Prepare, prime and paint all existing lintels that are not replaced as part of Item #3 above.
5. Remove and reconstruct bulging, displaced or otherwise distressed portions of the masonry facade and exterior face of roof parapet. Remove interior finishes of the southwest corner of the west elevation to fully inspect the interior masonry wall. Rebuild portions of the interior masonry wall as encountered.

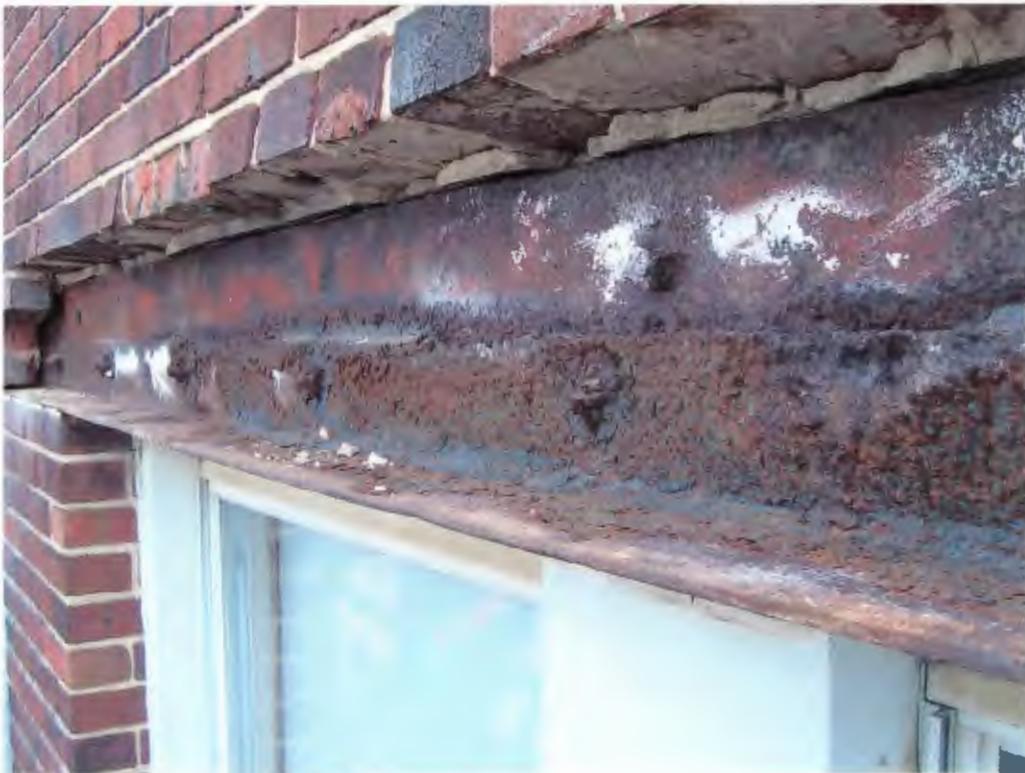
PHOTO 8 - Heavily corroded lintel with deteriorated steel rivets

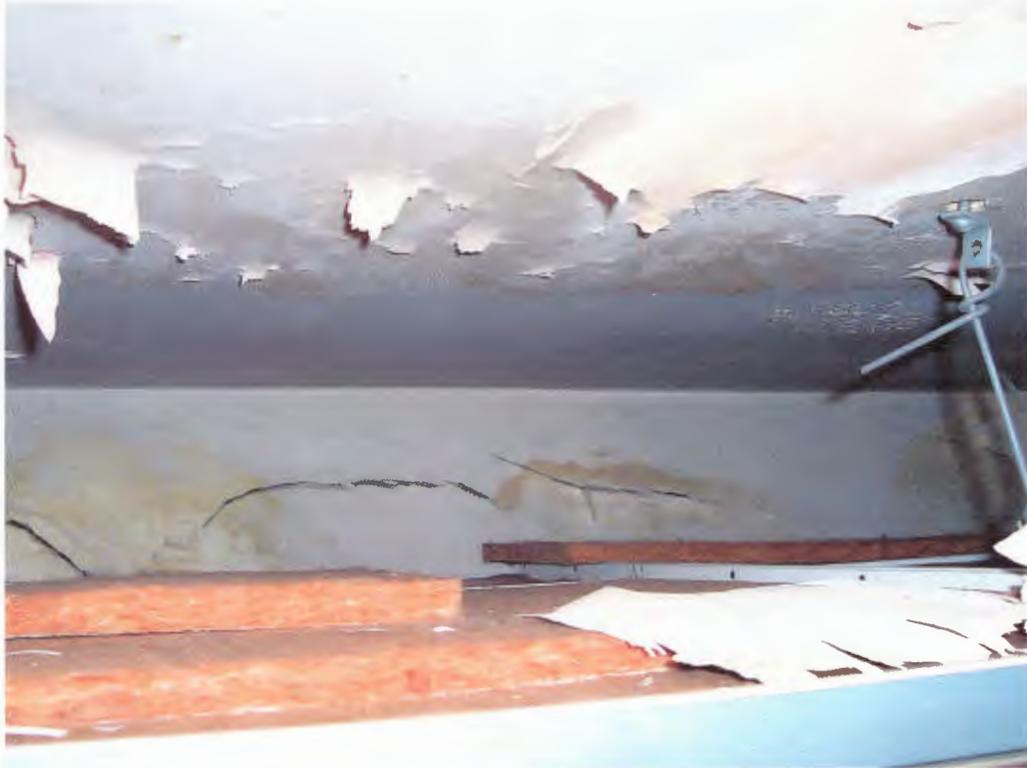
Our observations were primarily limited to the steel lintels that could be observed from the building exterior. Steel lintels within the wall or on the interior side of the wall are concealed by masonry and wall finishes respectively. We removed finishes in selected locations to observe the interior face of the wall in several locations on each side of the building. Only minor movement and brick deterioration was observed. This indicates that the facade deterioration as a result of lintel corrosion is likely concentrated to the exterior side of the wall. One location observed at the southwest corner of the building did exhibit advanced interior wall cracking and movement. This area will likely require that portions of the interior finishes be removed and selective portions of the interior face of the wall be dismantled and reconstructed or stabilized as necessary.

PHOTO 9 - Heavily cracked interior back-up wall at southwest corner of the west elevation

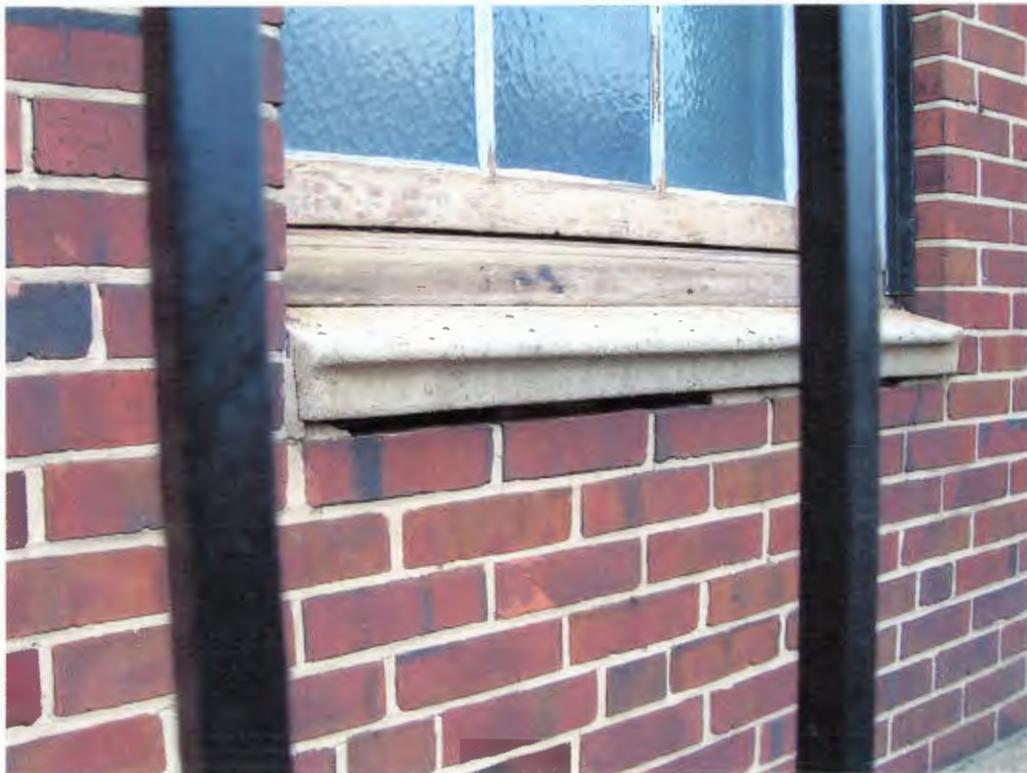
The condition of the brick mortar varied throughout the building elevations observed. The main entrance (west elevation) mortar appeared to be original on the lower half of the elevation. The upper half appeared to have been cut out and replaced with new mortar (tuckpointed) at some point in the past. The original mortar appeared to have eroded and was soft as a result of exposure and freeze/thaw deterioration. Cracks were also observed within the mortar of the upper half of the elevation as a result of freeze/thaw deterioration and wall movement as discussed above. Masonry absorption tests were performed on the original mortar of the west elevation and indicated that the mortar readily absorbed water.

PHOTO 10 - Deteriorated mortar beneath precast windowsill

6. Install epoxied dowels or other form of additional lateral support between masonry wythes during reconstruction of locations defined by Item #5.
7. Remove and replace damaged or deteriorated brick and brick mortar throughout the facades.

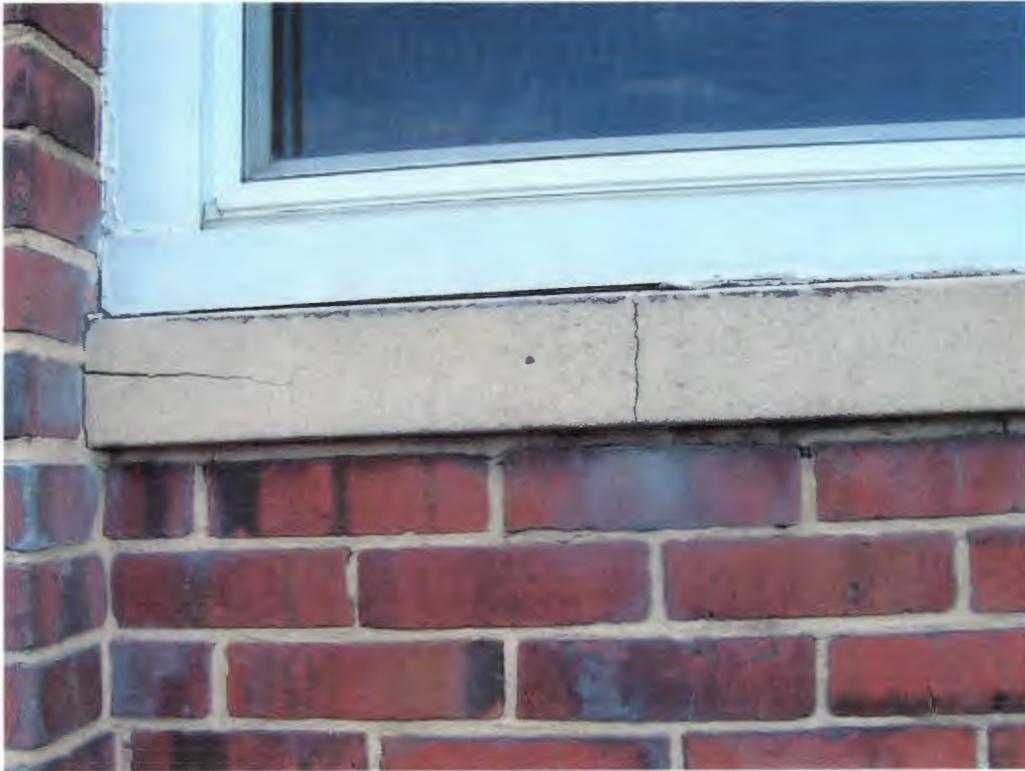
- Precast concrete windowsills were present on the west elevation. The sills exhibited spalling, weathering, cracking, erosion, and general deterioration in various locations. These conditions can permit water to enter the wall and promote the various failure mechanisms discussed previously.

PHOTO 11 - Cracked and spalled precast concrete windowsill

11. Repair/replace damaged, cracked, spalled, or otherwise deficient precast concrete windowsills on the west elevation. Coat all precast concrete windowsills and exposed portions of the pediment with a breathable cementitious coating.

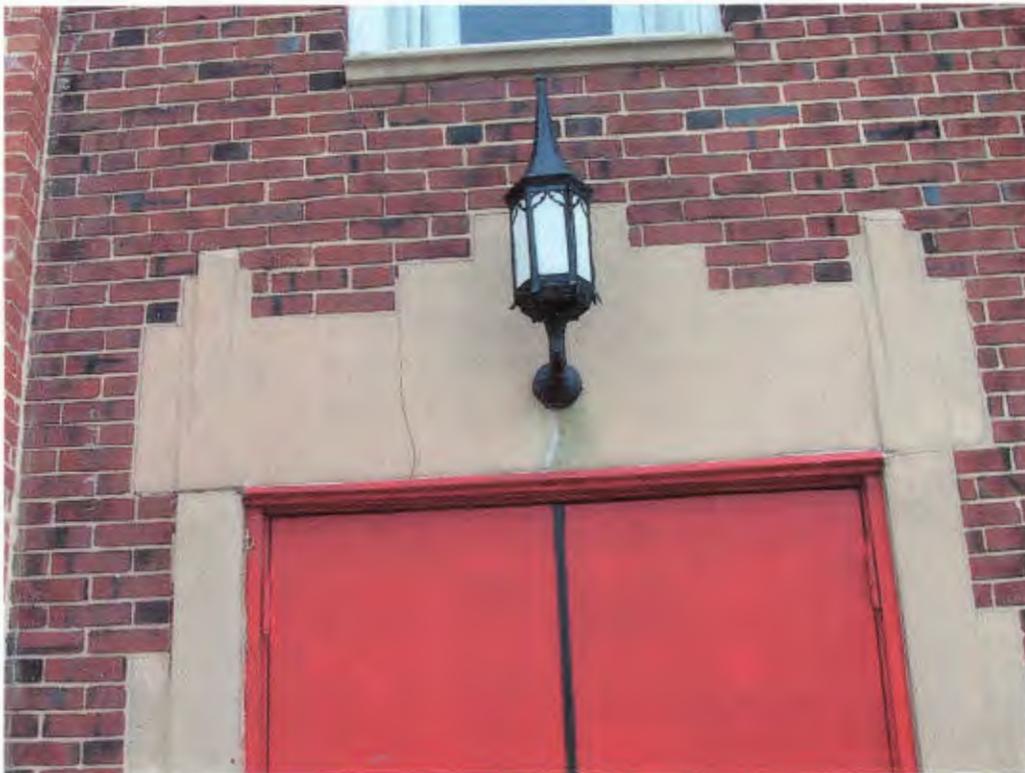
- Architectural precast concrete at the periphery of the main entrance door was cracked in one location. The crack allows water to enter the wall system at the periphery of the door and also detracts from the appearance of the precast concrete.

PHOTO 12 - Cracked precast concrete above the west elevation entrance door

12. Remove existing window and door sealants and other miscellaneous sealants within the facade and replace with new sealants.
13. Epoxy inject cracks in architectural precast concrete at the perimeter of the door on the main entrance (west elevation).

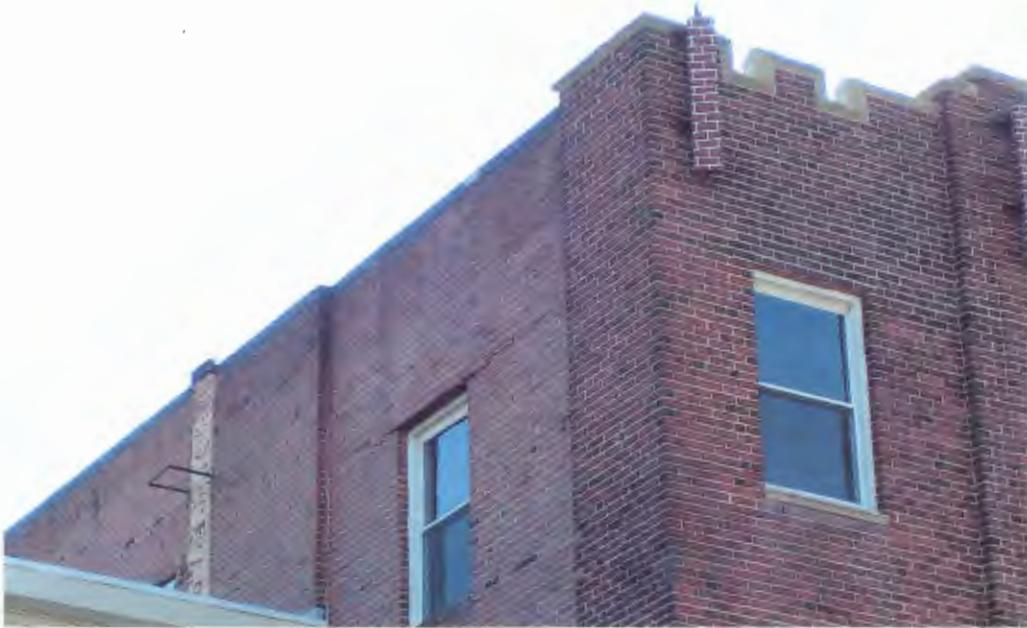
- A large amount of mortar residue on the north elevation indicated that a component of the building (i.e., chimney) had been removed at some point in the past. The mortar residue detracts from the overall appearance of the building.

PHOTO 13 - Corner of the north elevation with mortar residue from the previous chimney

14. Clean the north elevation of mortar residue remnants.
15. Remove concrete masonry units (block) within the wall of the east elevation and replace with brick masonry to match the existing.

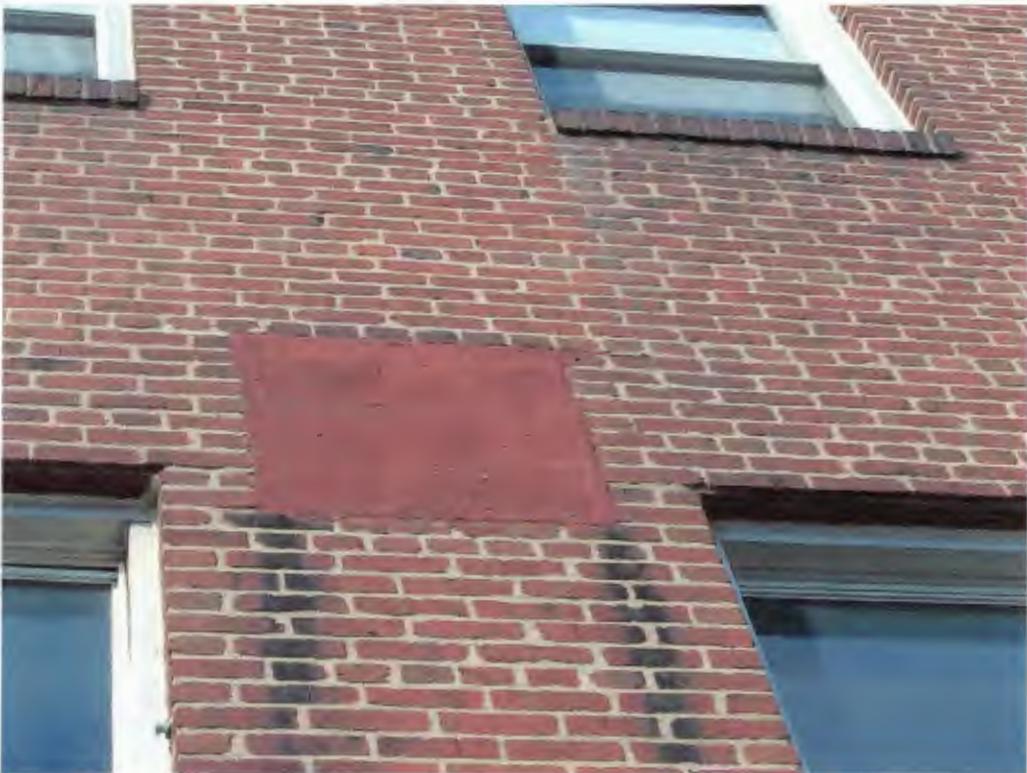
- An area of brick on the east elevation had been removed and infilled with concrete masonry units (block). The block detracts from the overall appearance of the building.

PHOTO 14 - Concrete block infill within the brick masonry wall of the east elevation
