October 30, 1998

United Evangelical Church  
3200 Dillon Street  
Baltimore, MD 21224-5028Attention: Mr. John Price, Property Manager  
Re: Bowed masonry walls over window openings

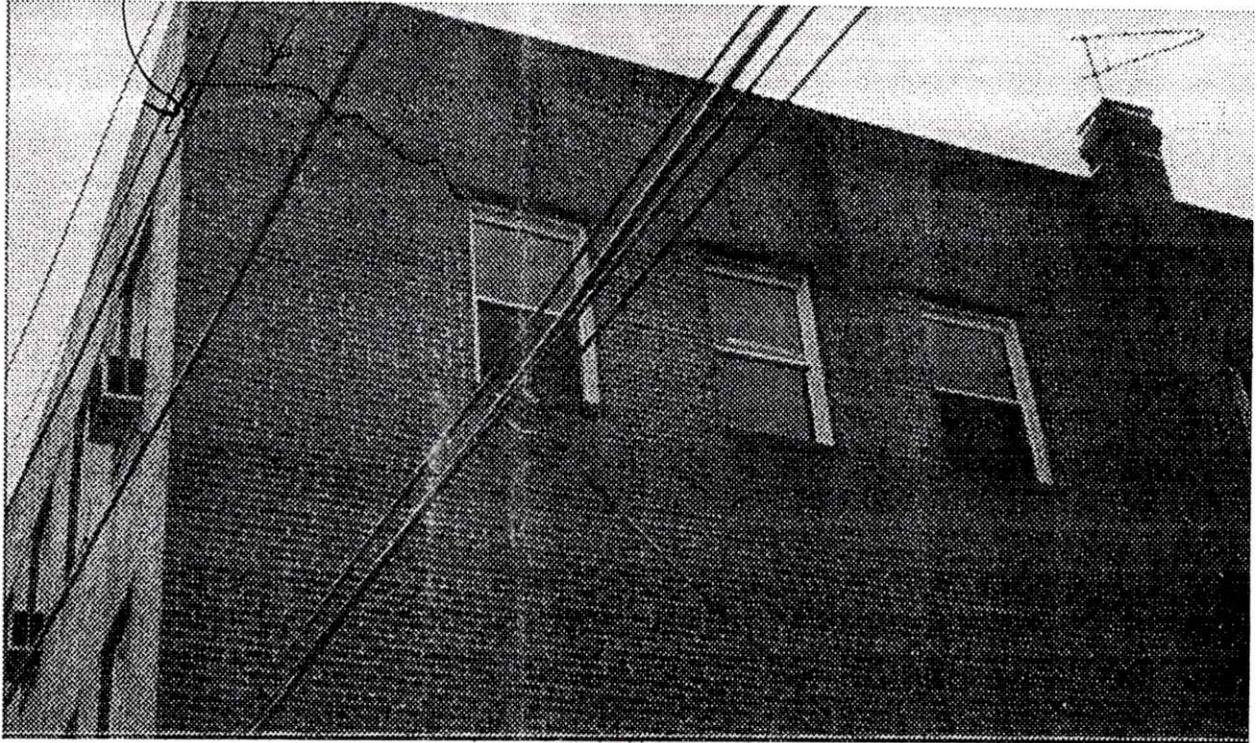
*Corner movement  
crack continues  
- should occur*

**Photo 1- Right rear of Building**

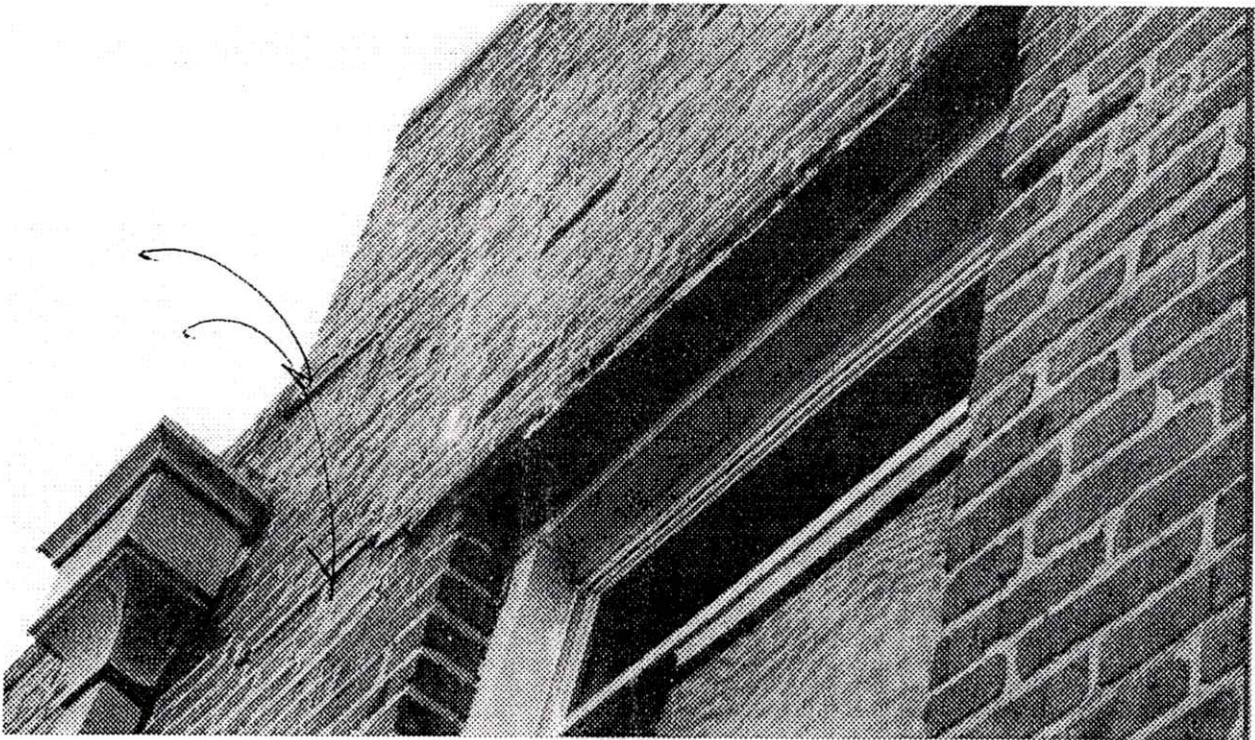
**Photo 2 - Cracked wall at scupper**

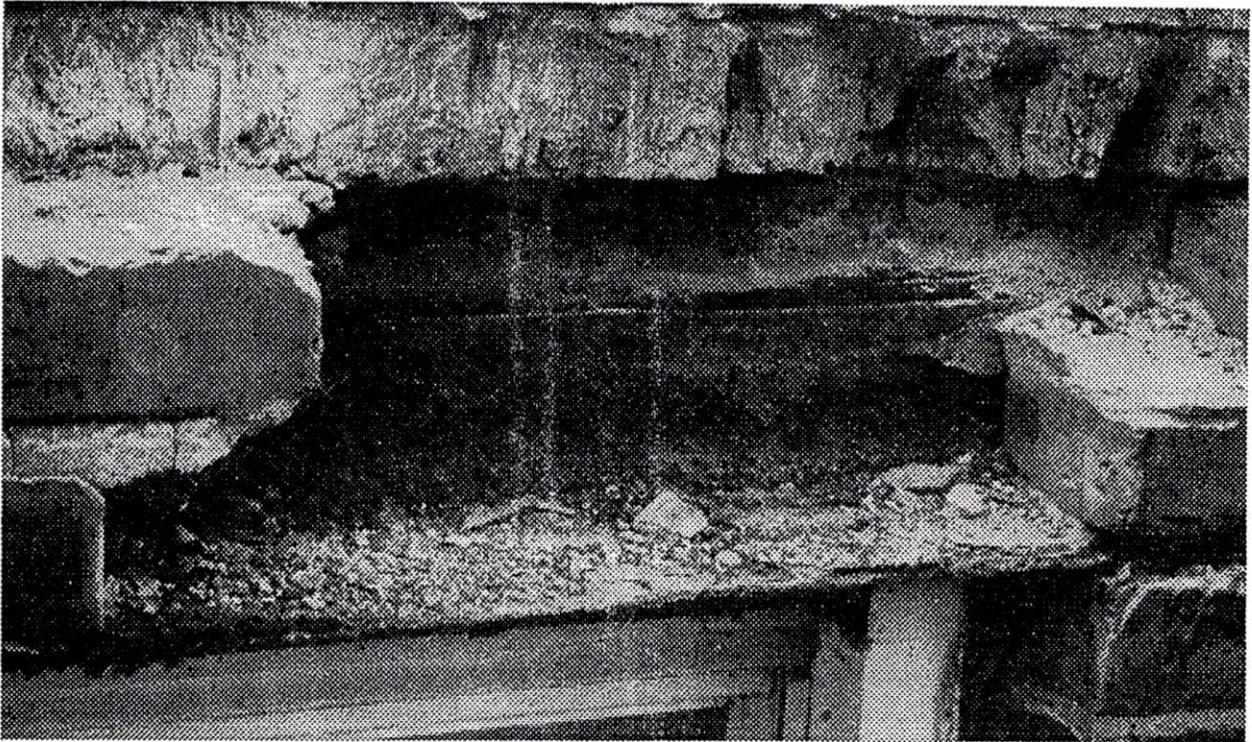
Water penetrating the building envelope has resulted in serious corrosion of steel angles (lintels) which support the brick above window openings. Oxidation of the steel has resulted in expansion of the steel resulting in bowing of the masonry supported by it above the windows. In some locations this expansion has forced a separation in the mortar bond in bricks whereby a distinct movement of brick can be observed. (Photo 2,4&6). The corrosion has decreased the original thickness of the steel angles to the extent that they have deflected. The supported brick has moved with the deflection and has begun to crack at mortar joints and through the brick thickness at some locations. Exterior brick should be manufactured with a hard-fired surface to restrict water absorption and deterioration. Brick specifications now require such specifications for manufacturing. Brick however is not completely impermeable nor is the mortar, and over time therefore, some deterioration in both is not unlikely.

**Photo 3 –Severely Corroded steel angles**

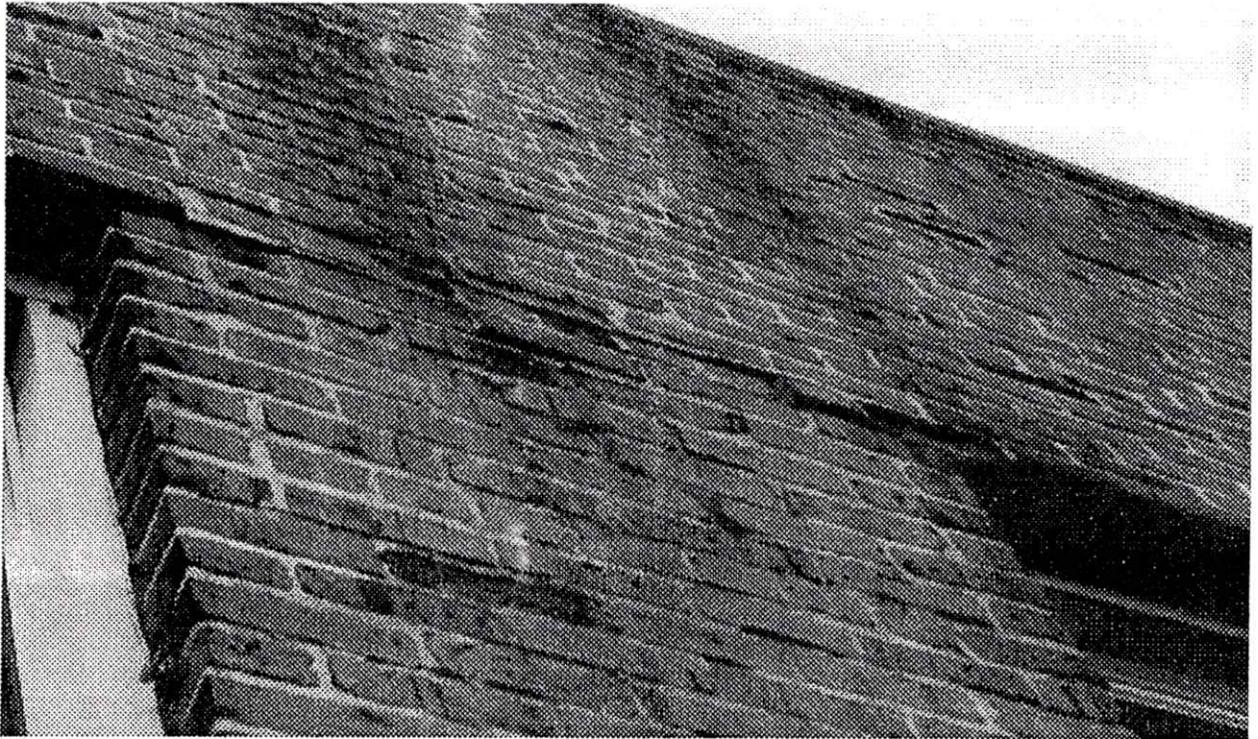
Moisture trapped in the walls and openings in both mortar and masonry will severely degrade the building life. When masonry roof parapets expand and contract more than the walls below, conditions such as the cracking shown on photos 4, 5 and 6 can occur and have occurred. The parapets are subjected to temperature and moisture extremes and sometimes pressure differentials which can drive the moisture through the wall to the wall cavity. Flashing and weep holes (holes which allow moisture to drain to the outside surface) when incorporated into the building design allow the moisture to drain to the exterior. Differential expansion from the building wall below can cause the parapets to bow, crack horizontally at the roofline and to overhang the corners. Observations from the exterior reflect both inward and outward movement. Actual determination of the cause of such movement is extremely complex. However we know that concrete slabs in the building can curl from shrinkage, deflect and if the slab warps it can damage the masonry. While these conditions can be planned for in new construction as numerous changes have been made to construction methods involving masonry walls and parapets, whereby allowances are made for construction and environmental tolerances.

**Photo 4 -Heavy water stains; brick face deterioration & separation**

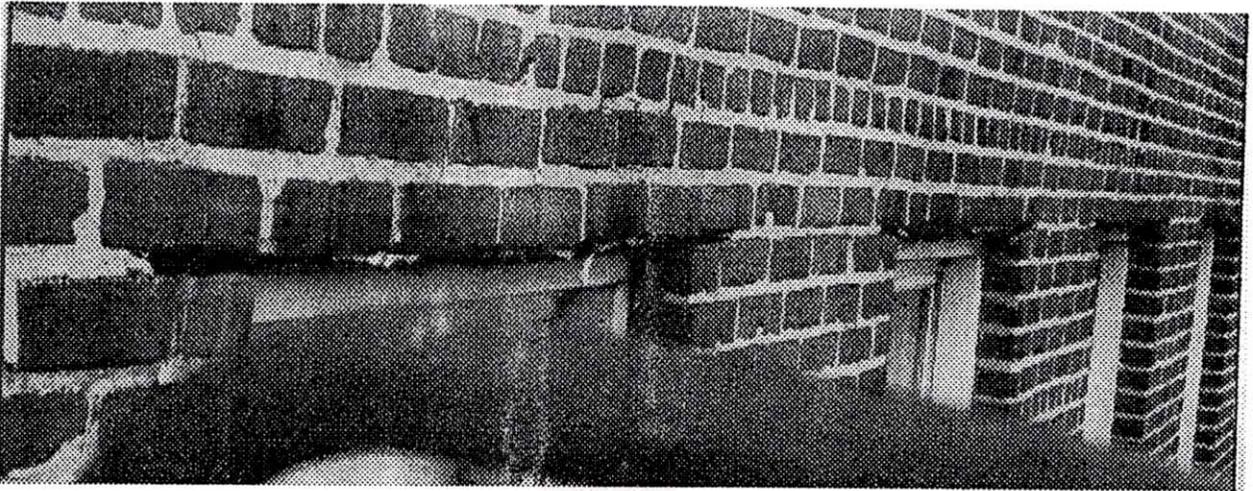
Photo 5- Excessive steel angle and masonry deflection

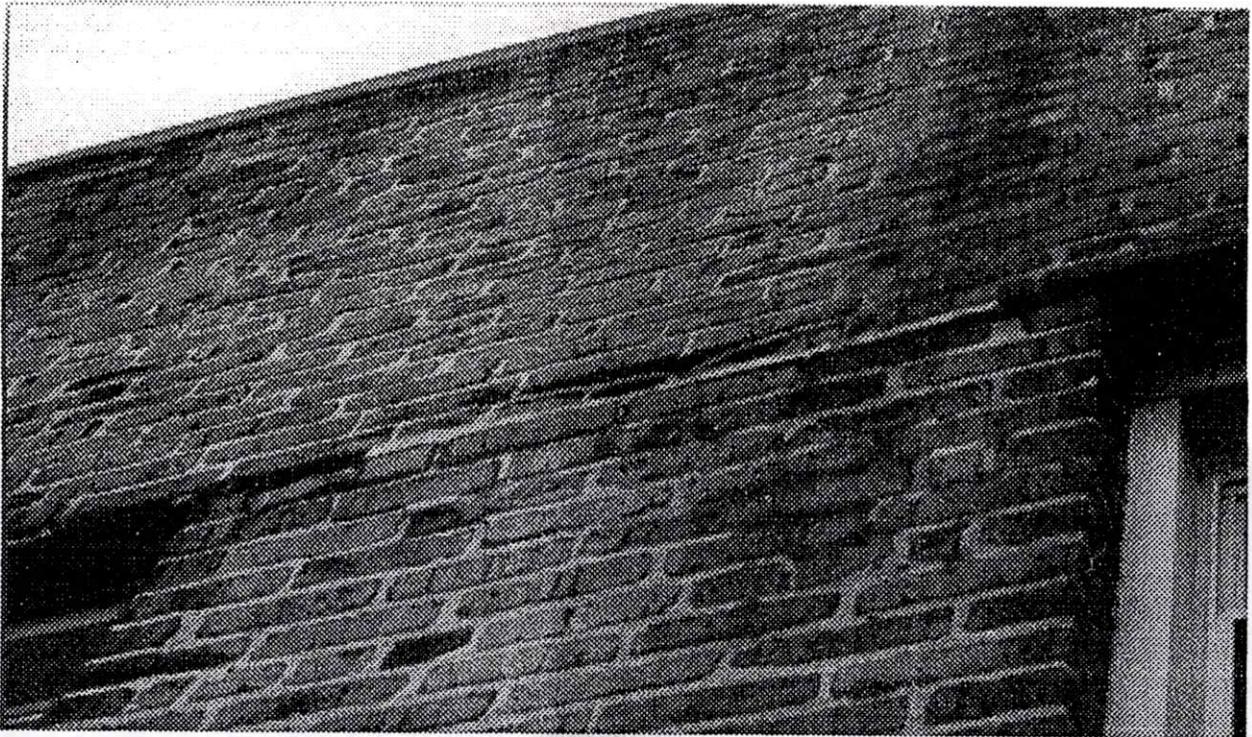
Photo 6- Heavy water staining, loose and failing brick and faces of brick. Wall separation

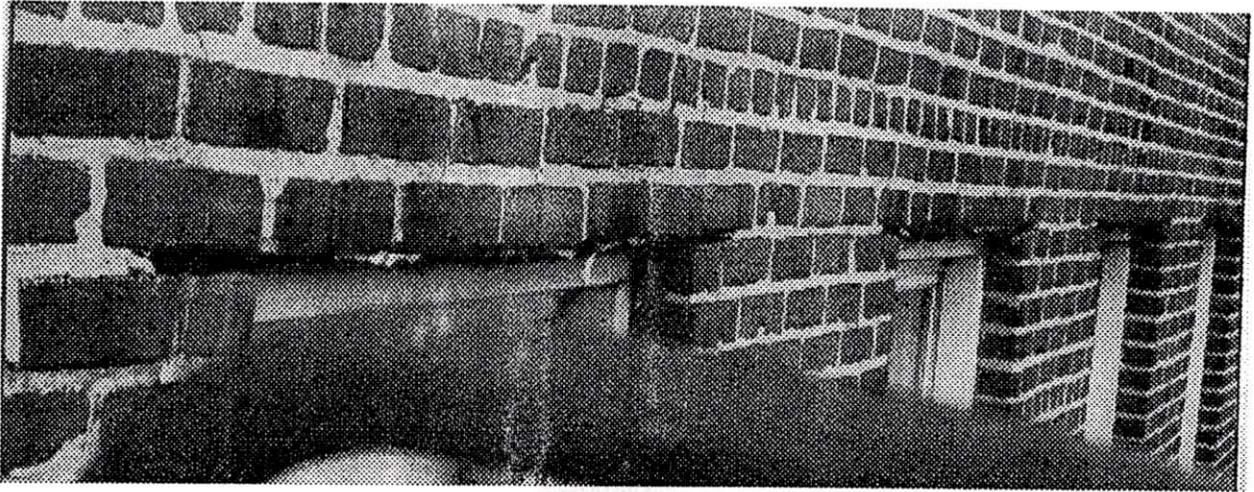
Photo 5- Excessive steel angle and masonry deflection

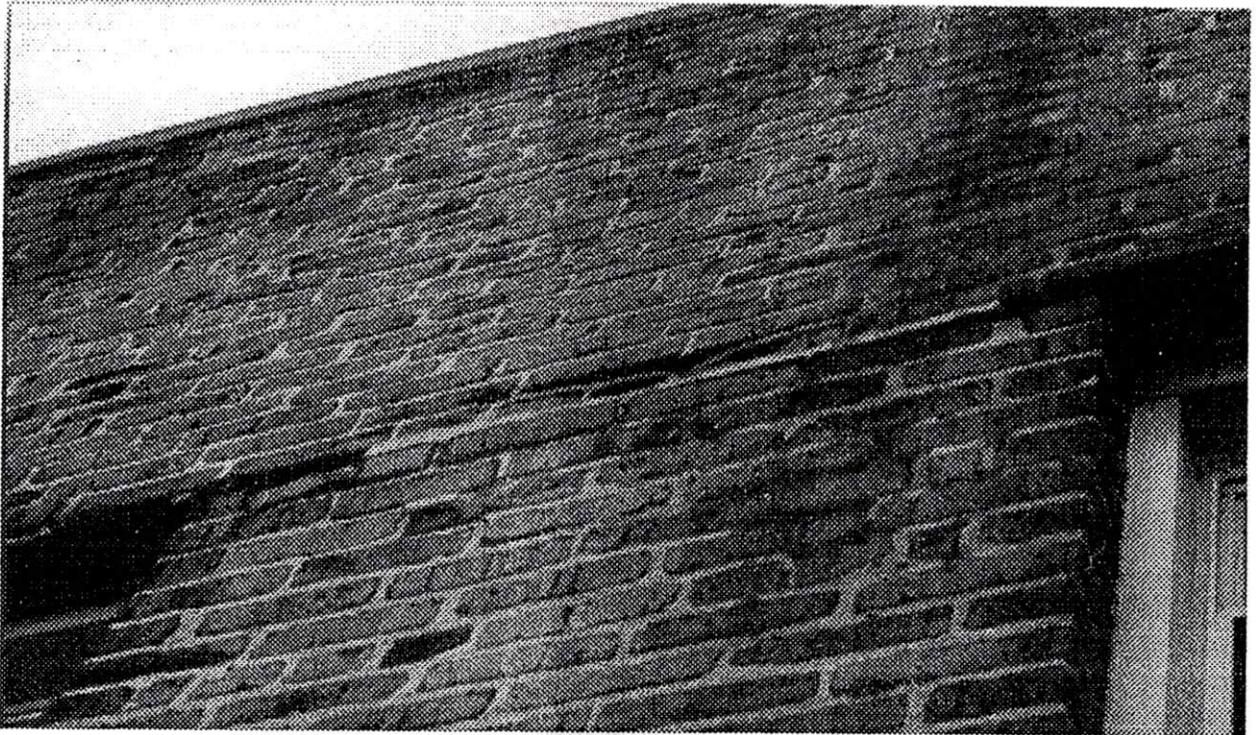
Photo 6- Heavy water staining, loose and failing brick and faces of brick. Wall separation

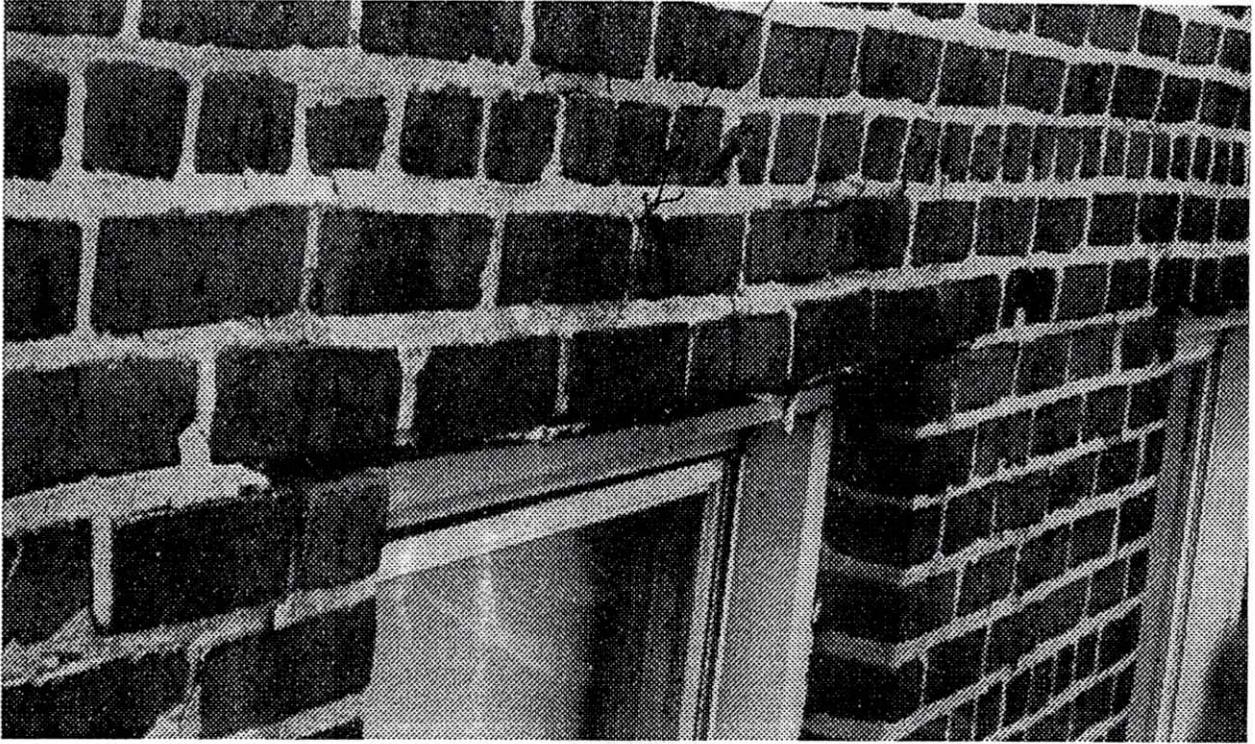
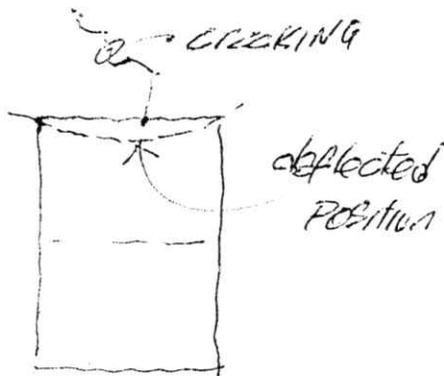
Photo 7-Severely deflected steel angle and masonry

cracks above  
in mortar line

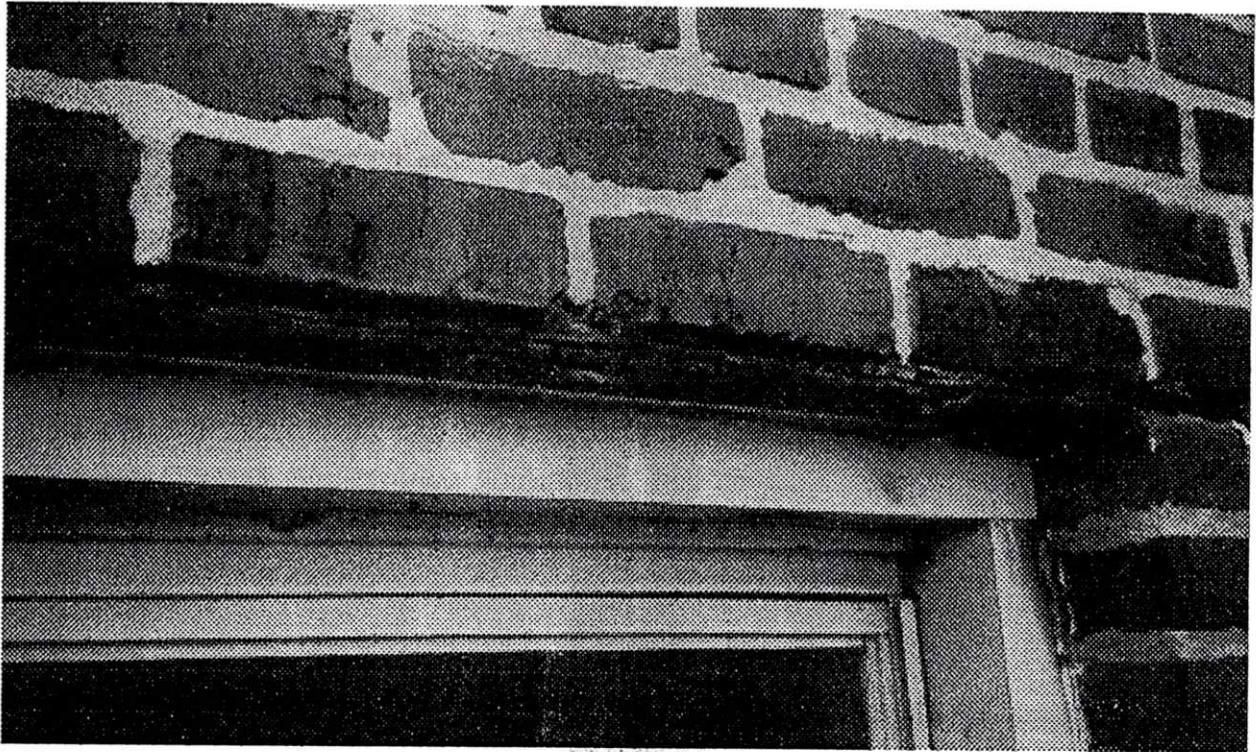
Photo 8- Severe steel lintel corrosion and mortar failure

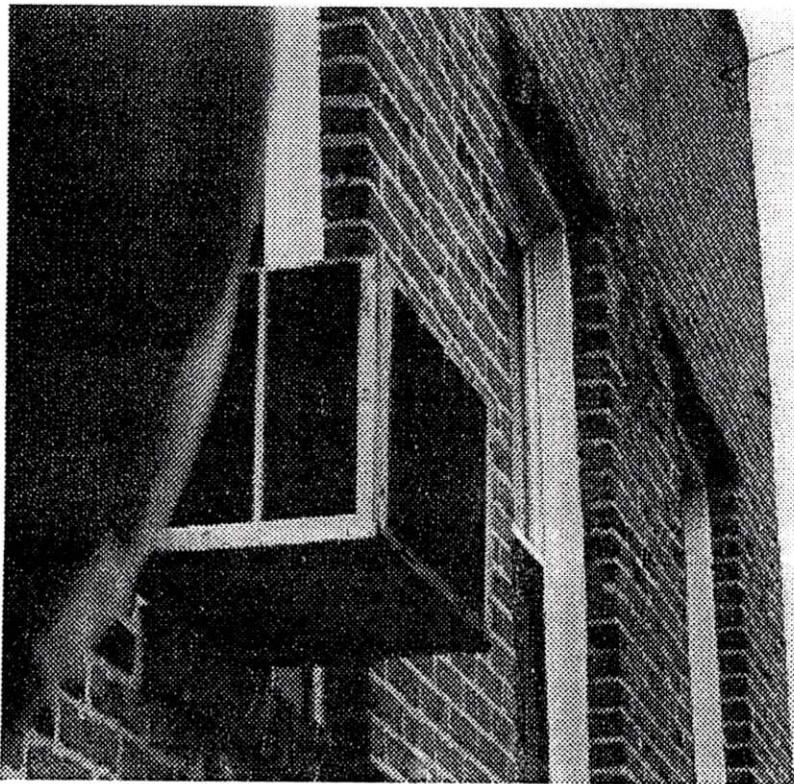
OUTWARD  
MOVEMENT  
&  
CRACKING

Photo 9- Mortar cracking at upper corner of wall

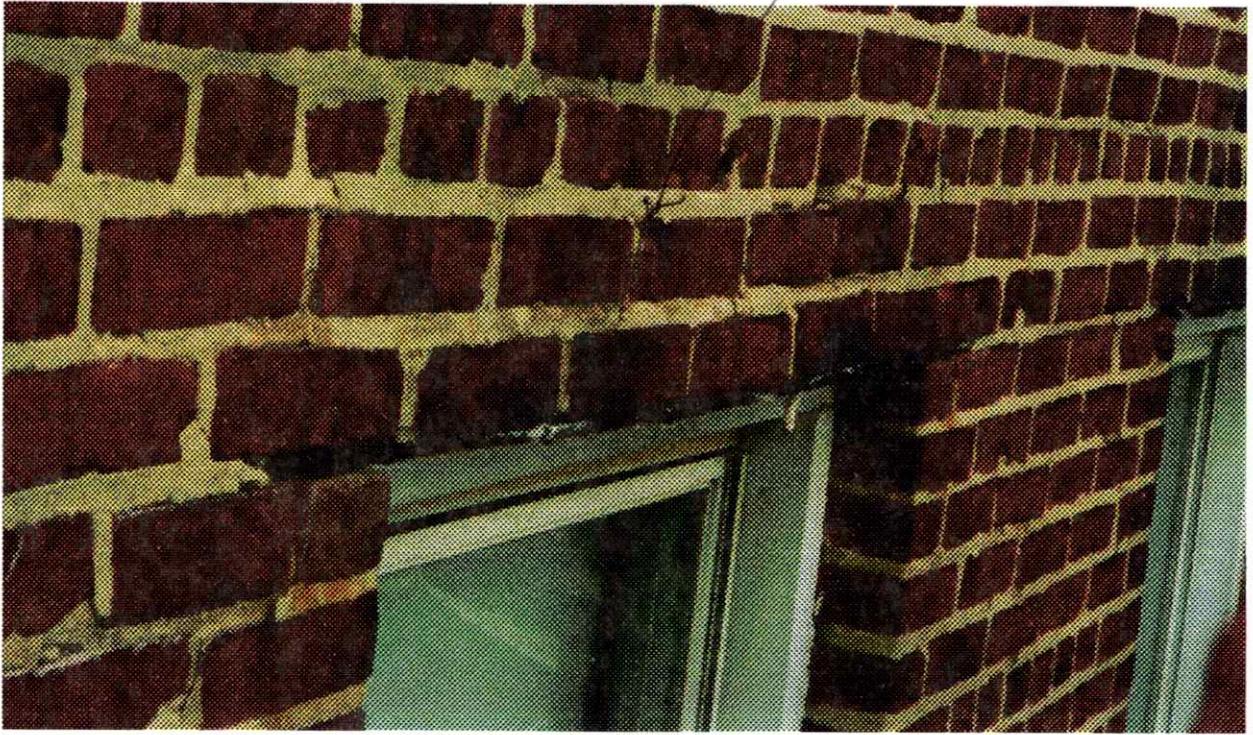
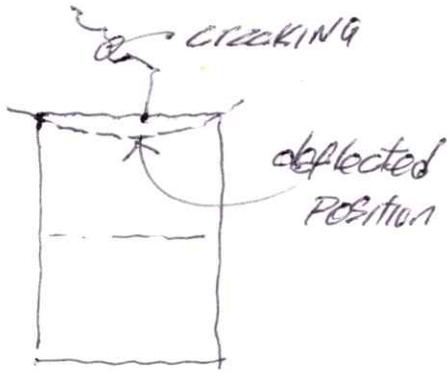
Photo 7-Severely deflected steel angle and masonry

cracks above  
in mortar line

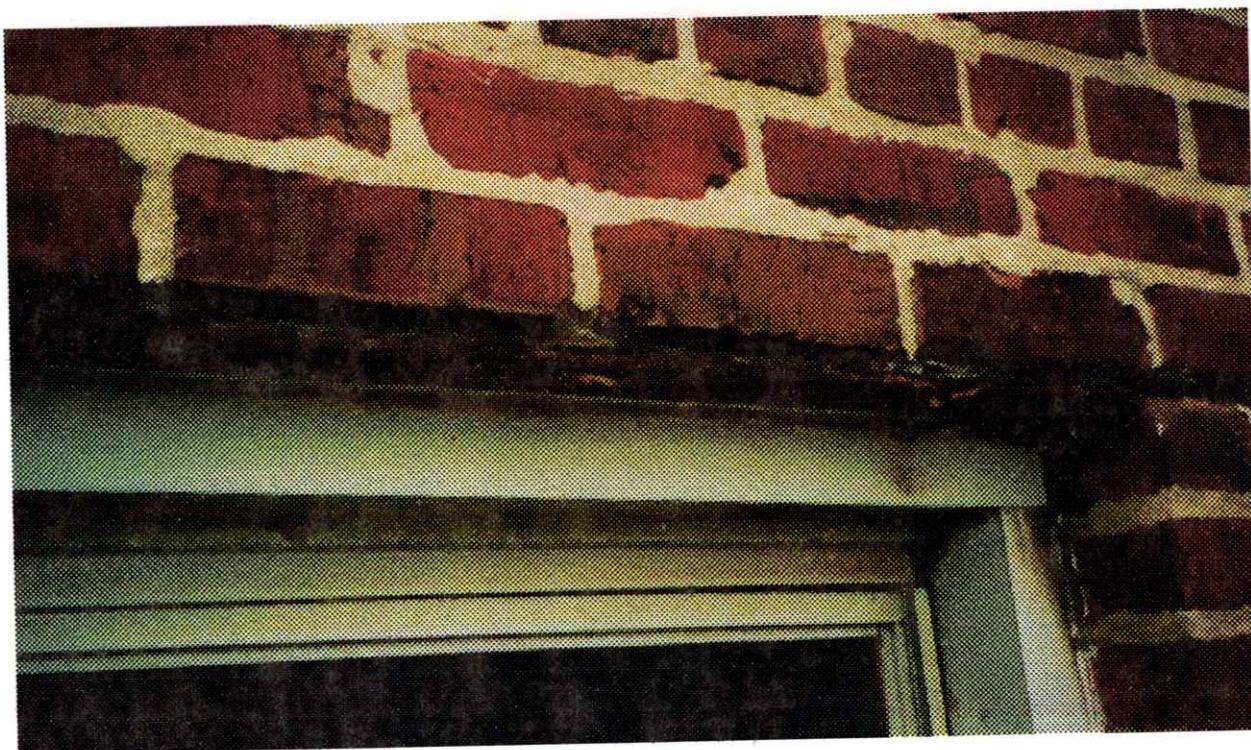
**Photo 8- Severe steel lintel corrosion and mortar failure**

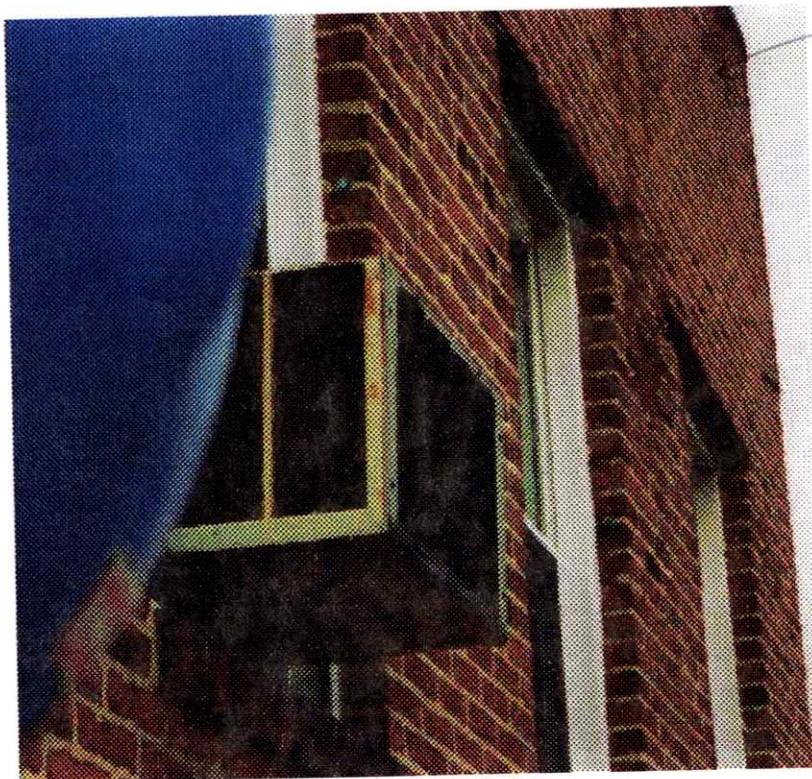
*OUTWARD  
movement  
&  
CRACKING*

**Photo 9- Mortar cracking at upper corner of wall**

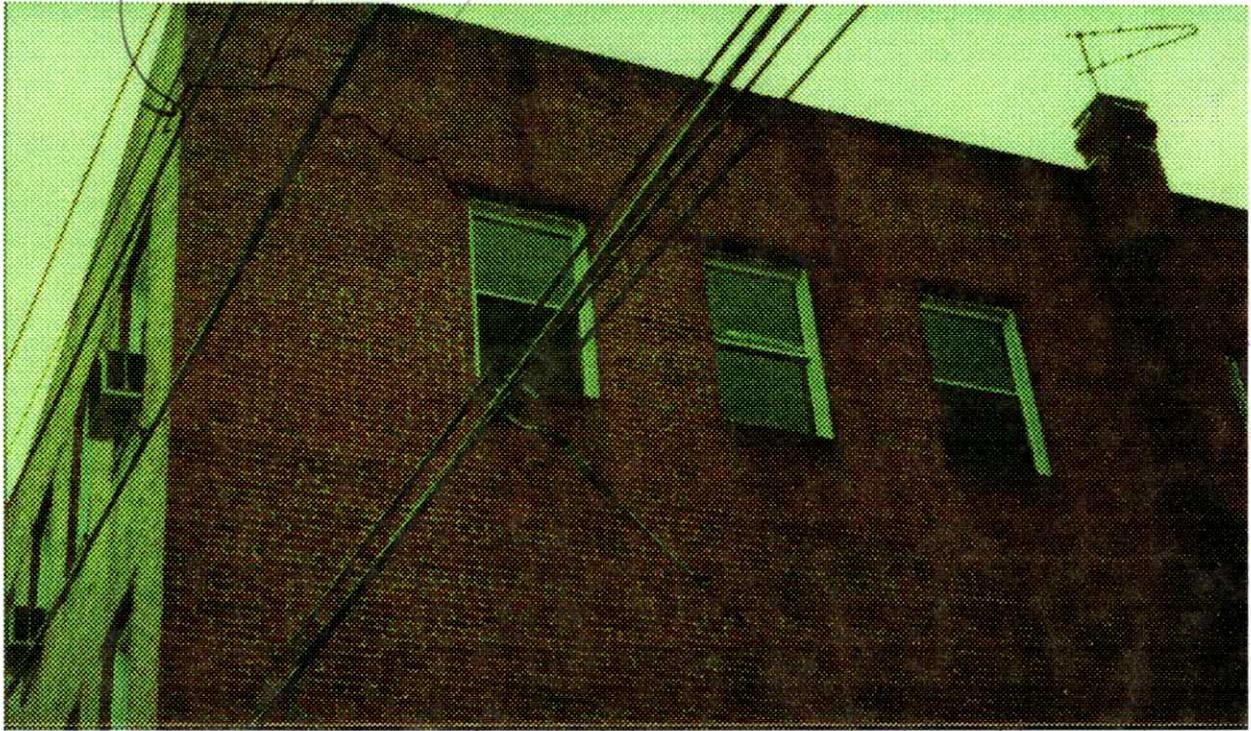
corner movement  
crack continues  
around corner

**Photo 1- Right rear of Building**

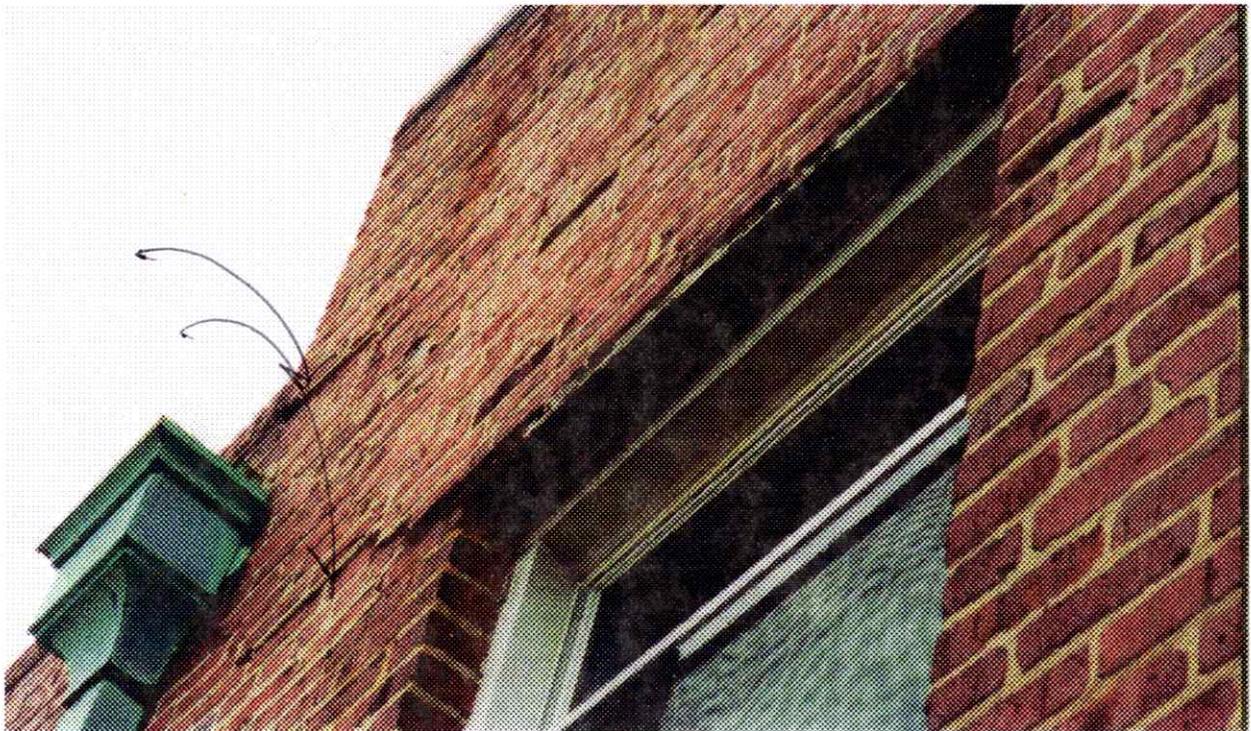
**Photo 2 -Cracked wall at scupper**

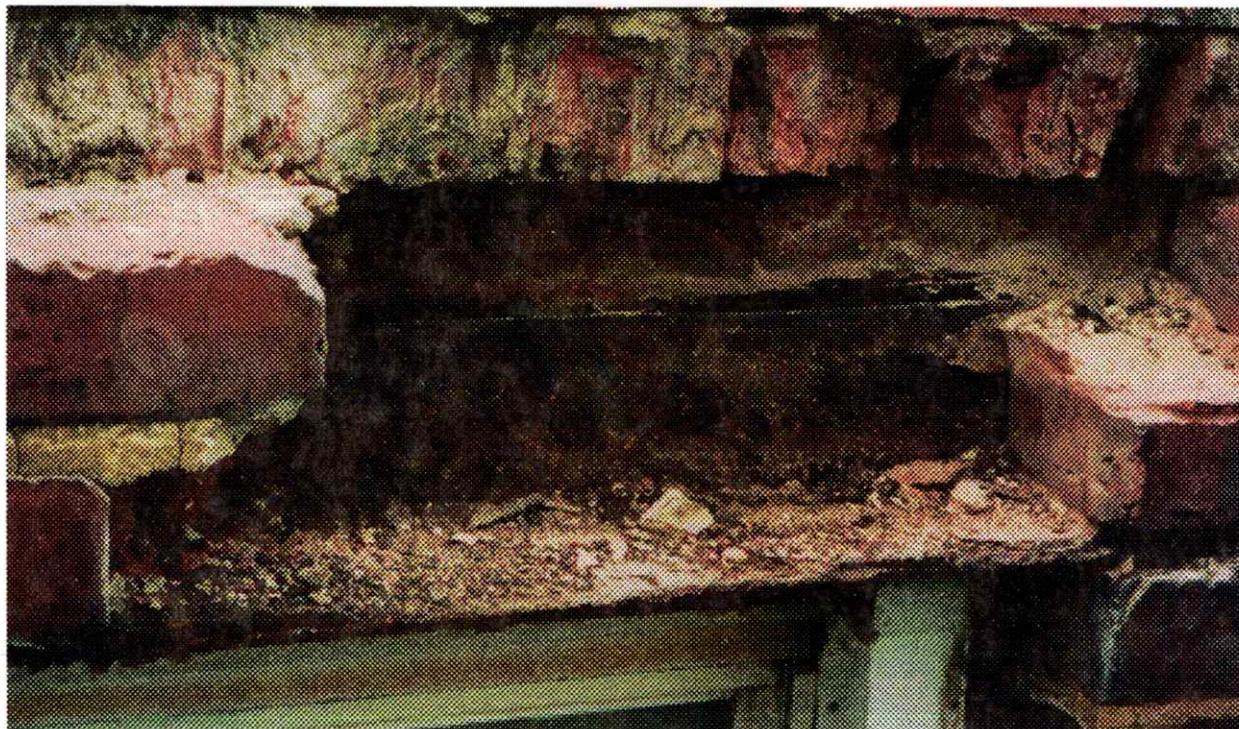
**Photo 3 –Severely Corroded steel angles**

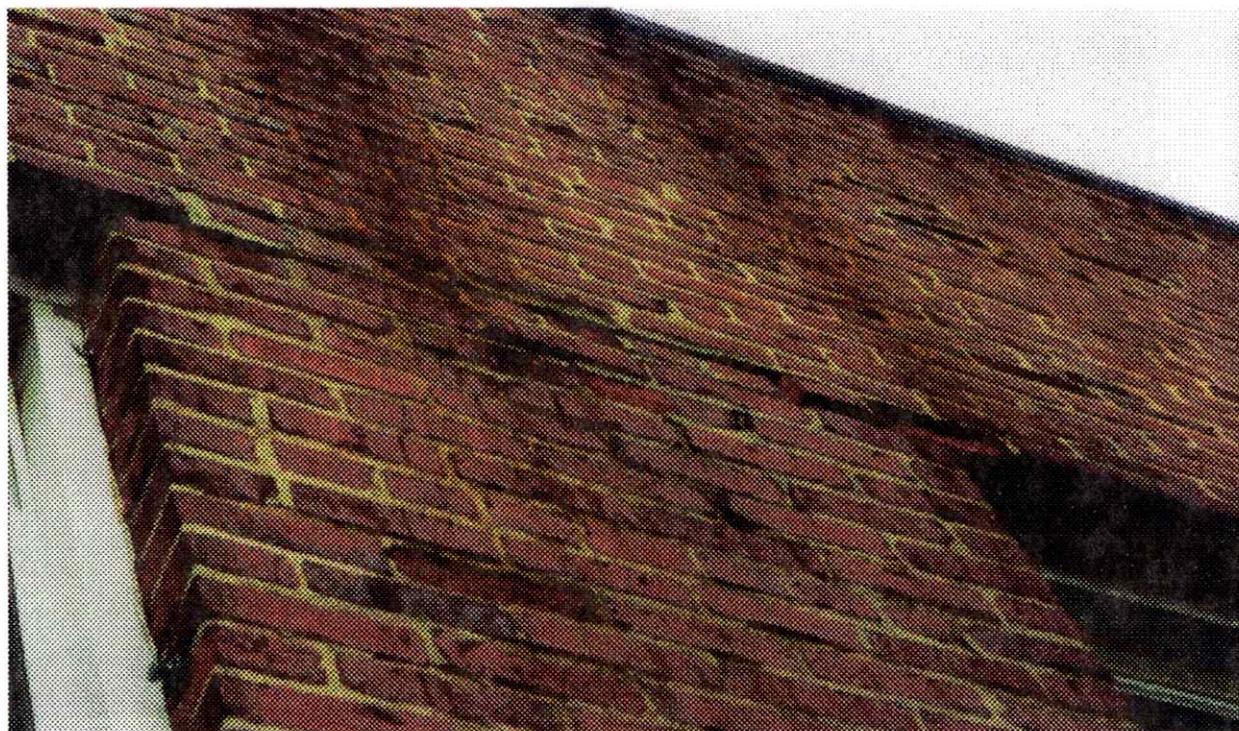
**Photo 4 -Heavy water stains; brick face deterioration & separation**

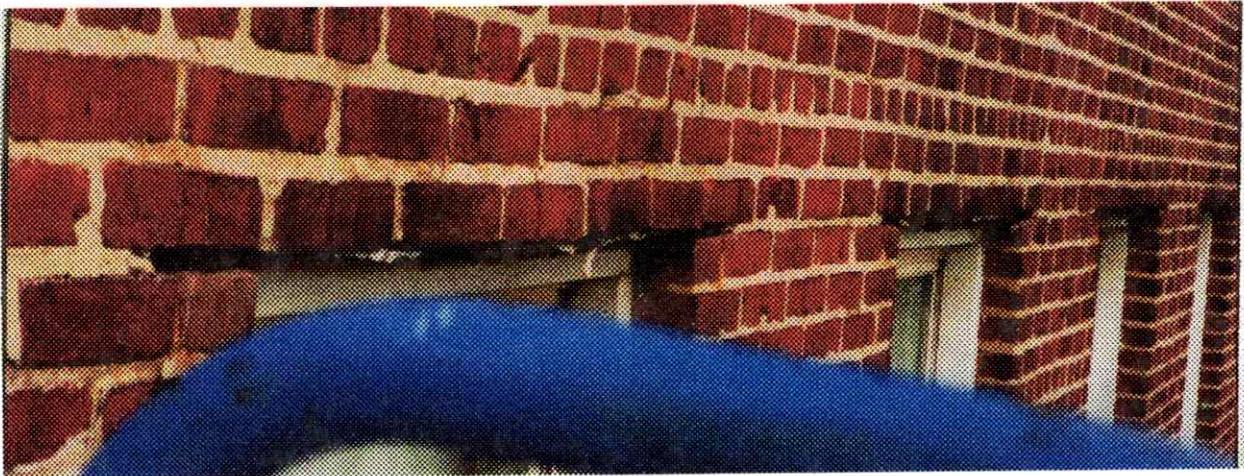
**Photo 5- Excessive steel angle and masonry deflection**

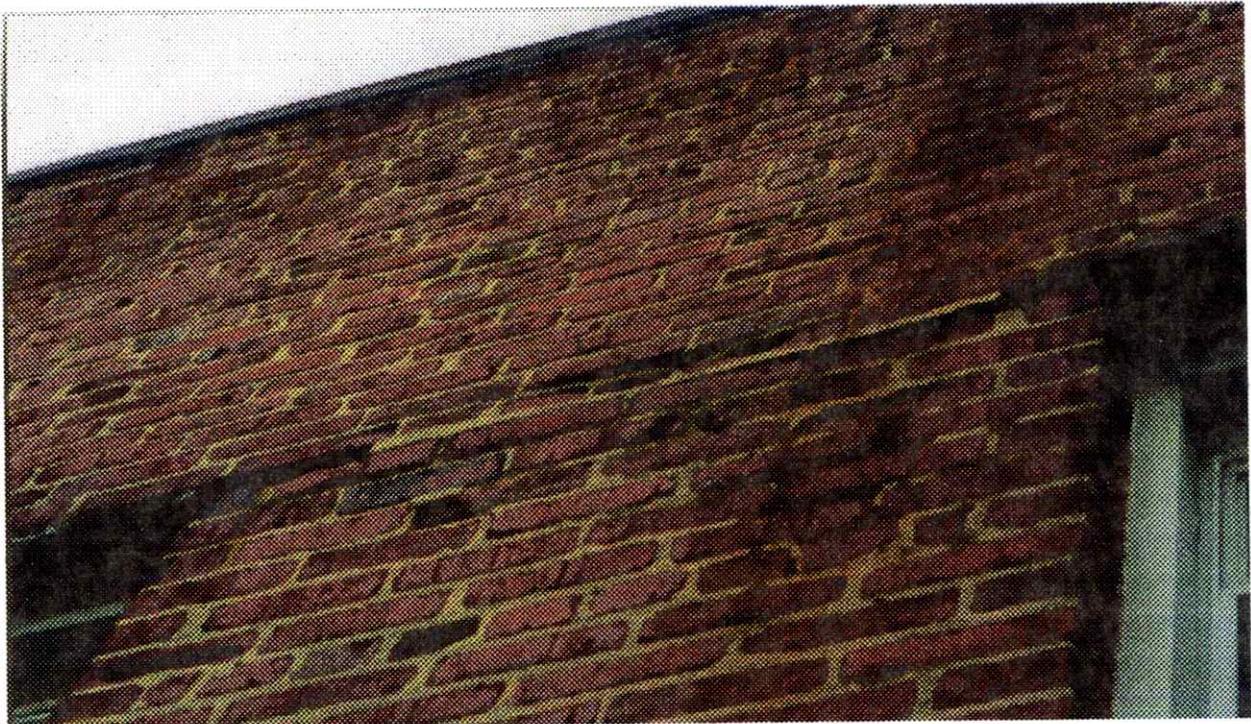
**Photo 6- Heavy water staining, loose and failing brick and faces of brick. Wall separation**
