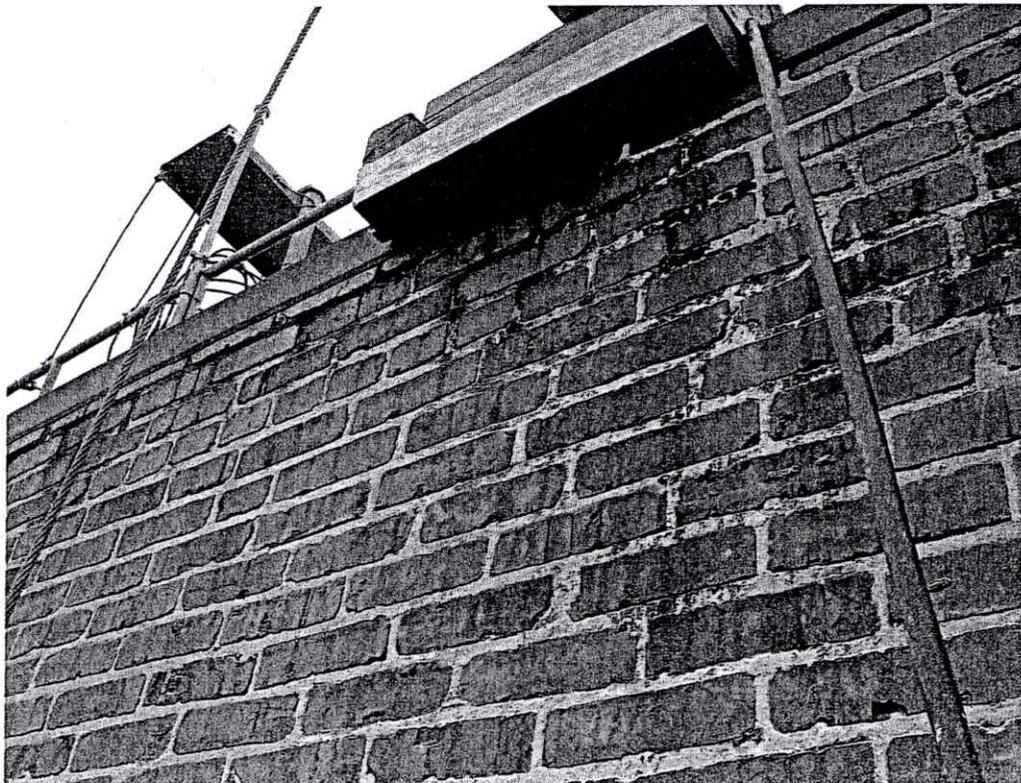
PHOTO 2 - Facade stains from the corroded metal roof parapet coping

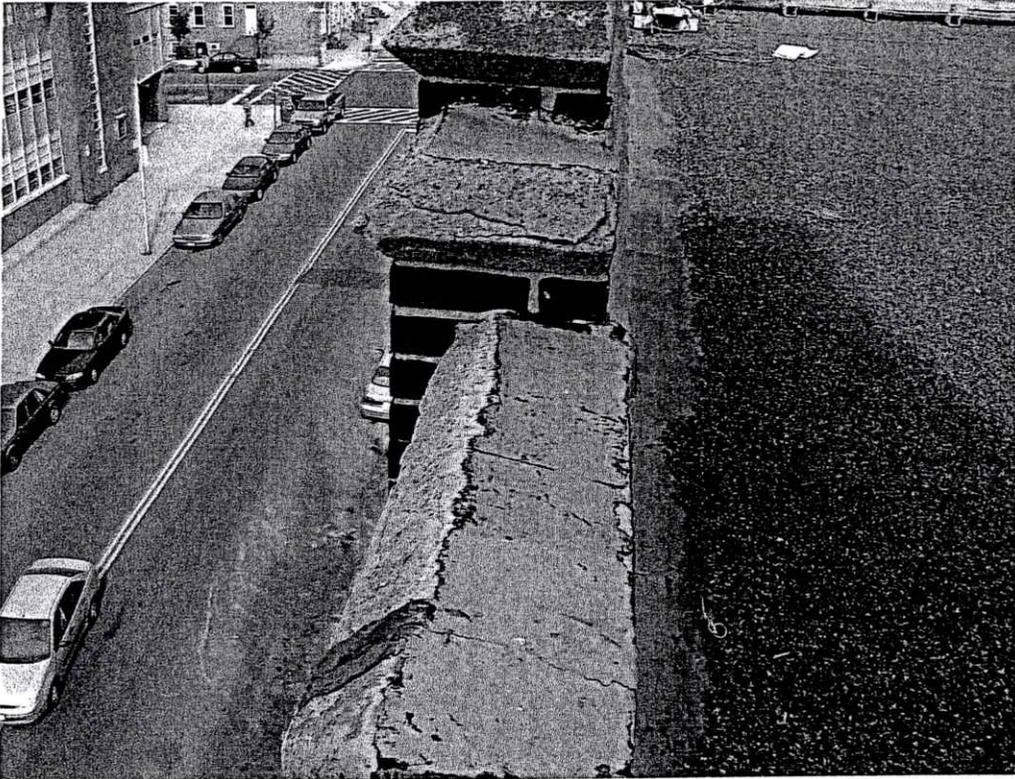
PHOTO 3 - Existing cracked and spalled precast concrete coping

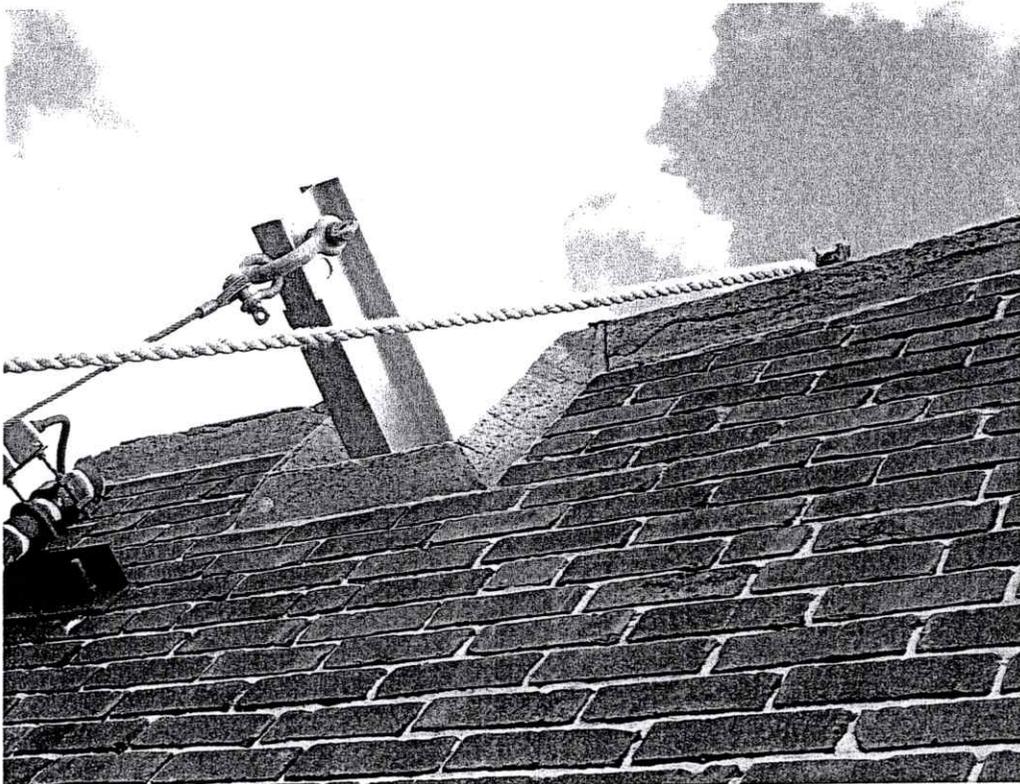
PHOTO 4 - Existing cracked and spalled precast concrete coping

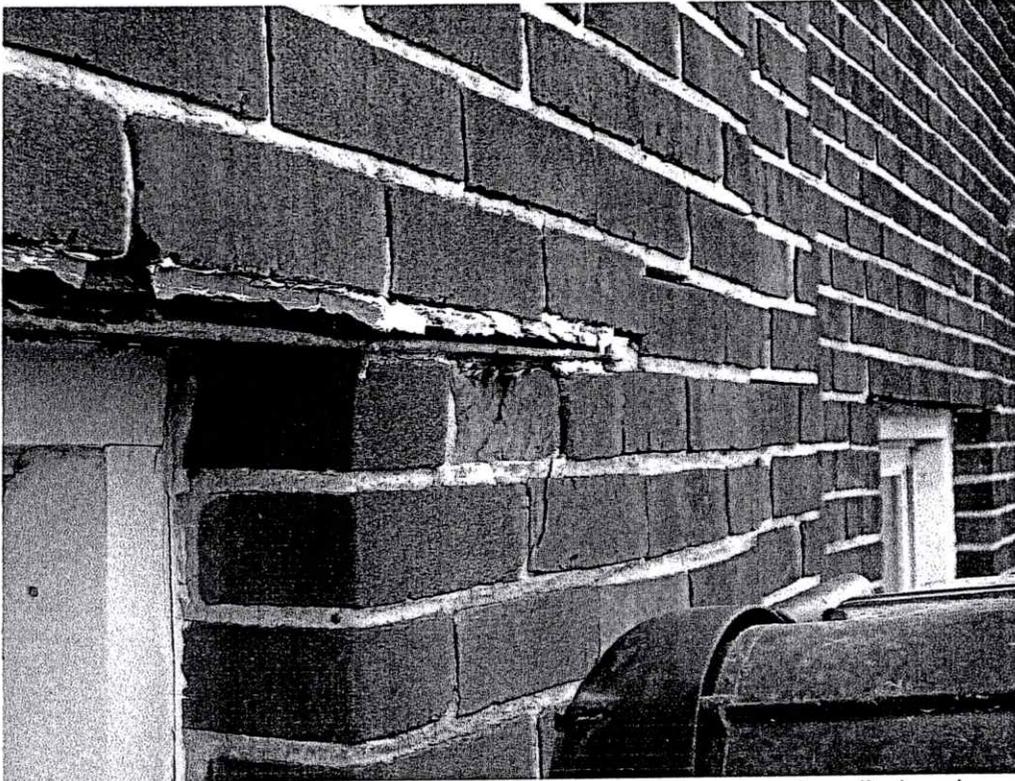
PHOTO 5 - Example of existing lintel deterioration with associated spalled and cracked brick

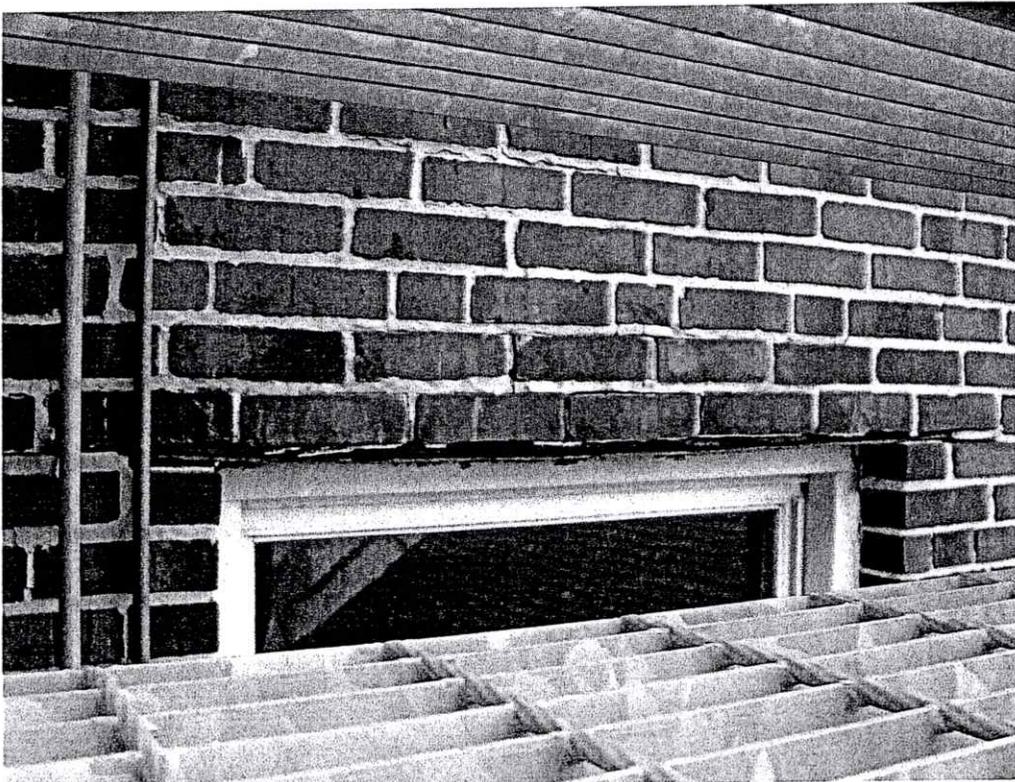
PHOTO 6 - Example of existing lintel deterioration

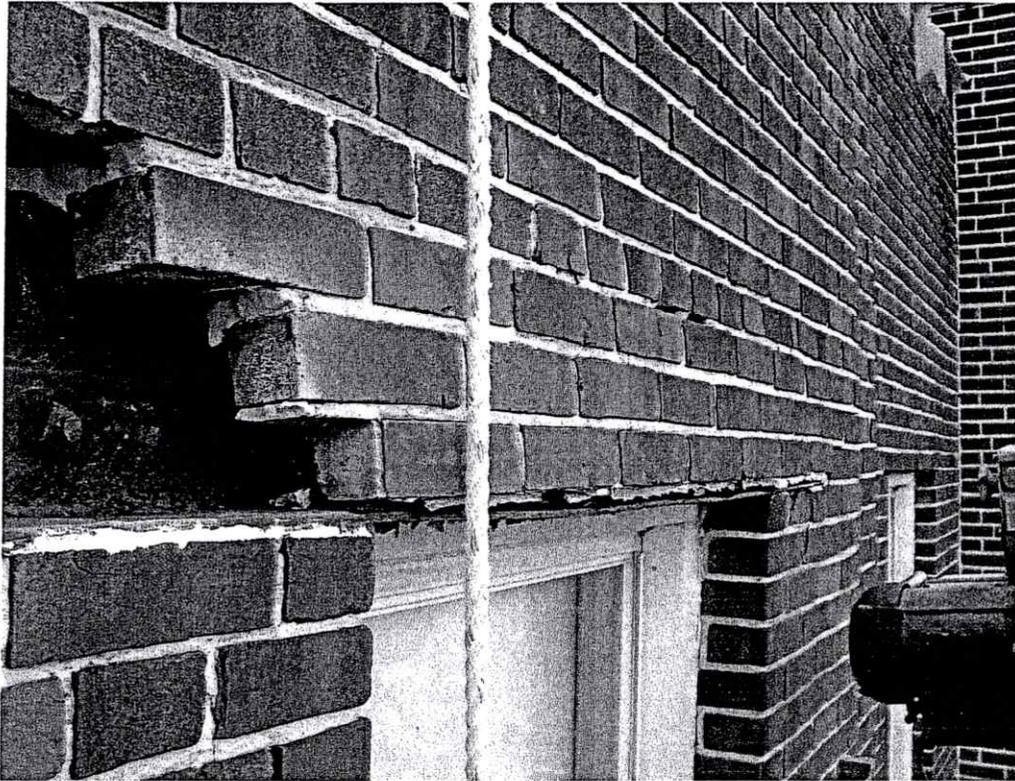
PHOTO 7 - Bulging portion of the facade above deteriorated lintel

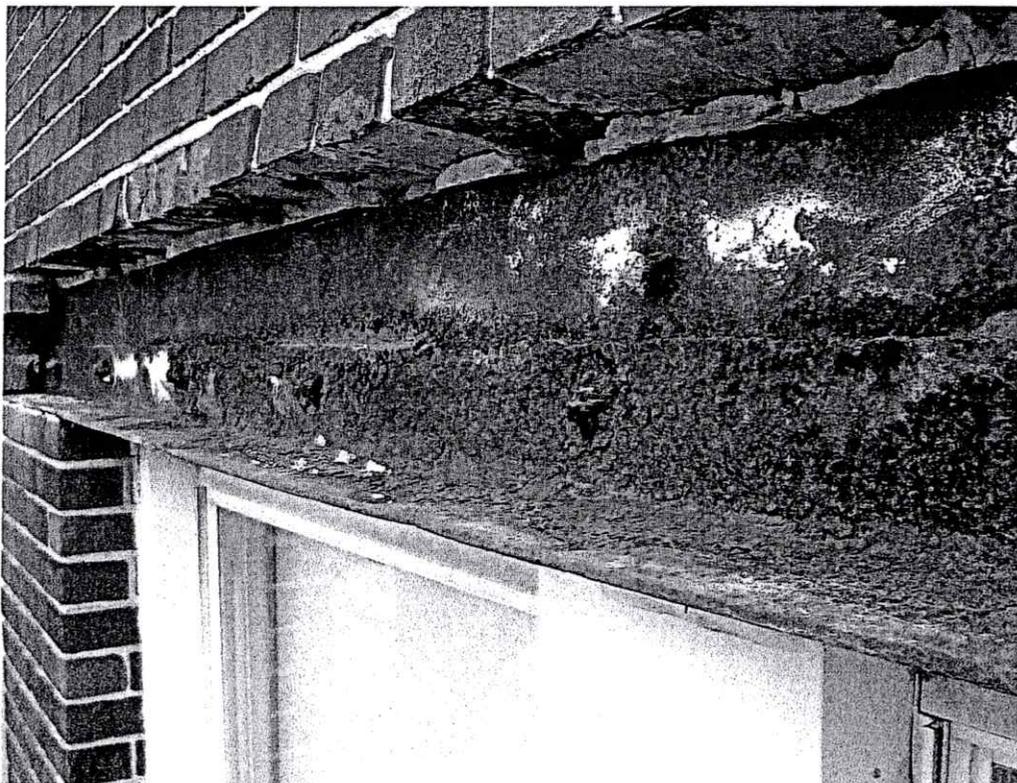
PHOTO 8 - Heavily corroded lintel with deteriorated steel rivets

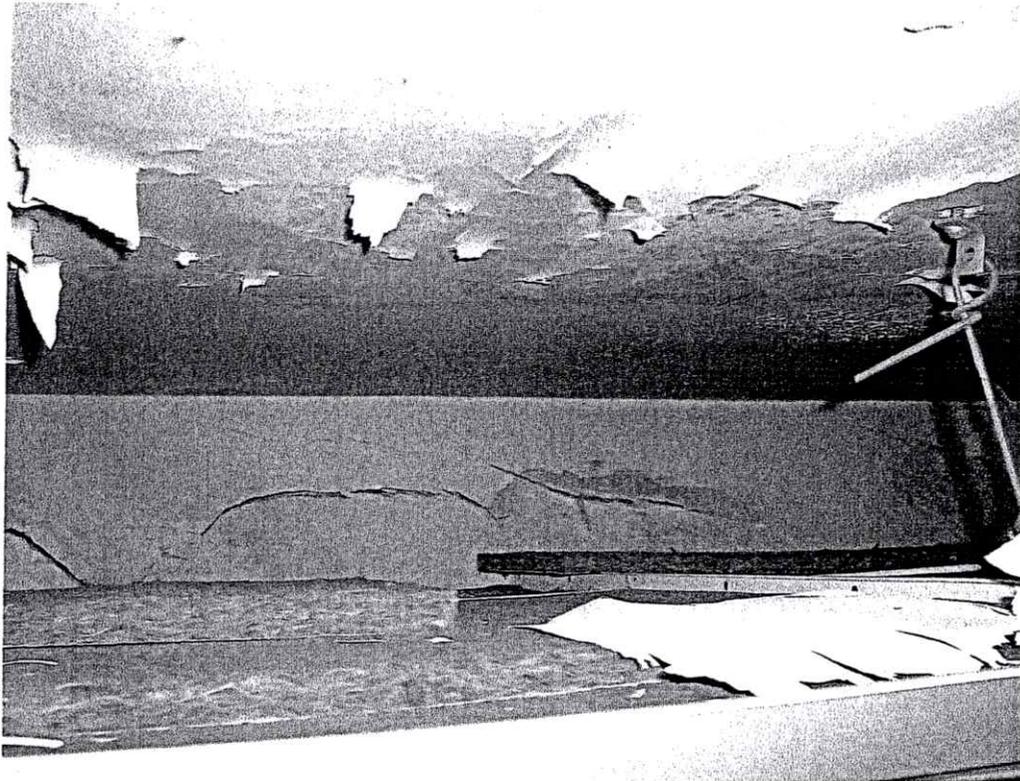
PHOTO 9 - Heavily cracked interior back-up wall at southwest corner of the west elevation

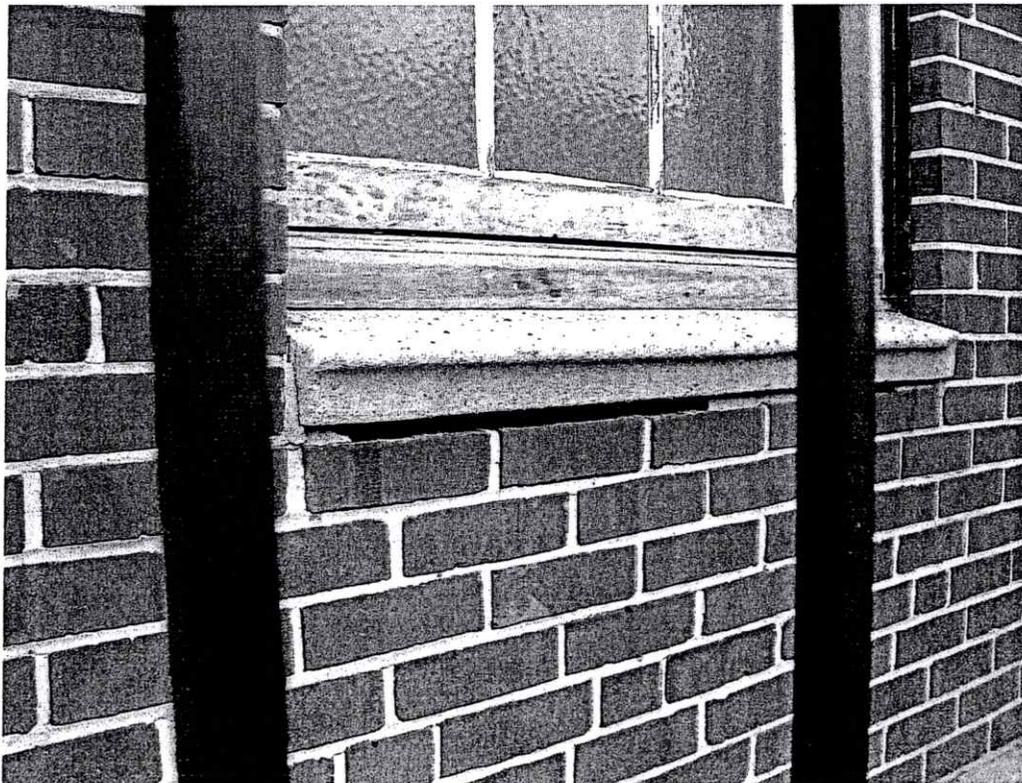
PHOTO 10 - Deteriorated mortar beneath precast windowsill

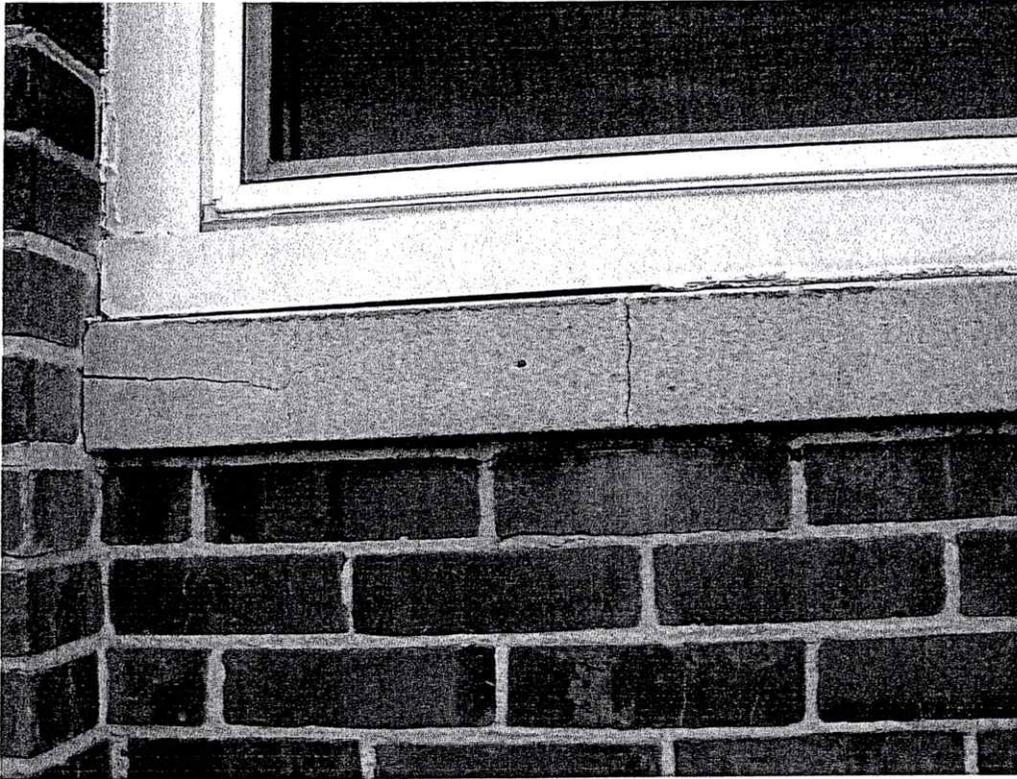
PHOTO 11 - Cracked and spalled precast concrete windowsill

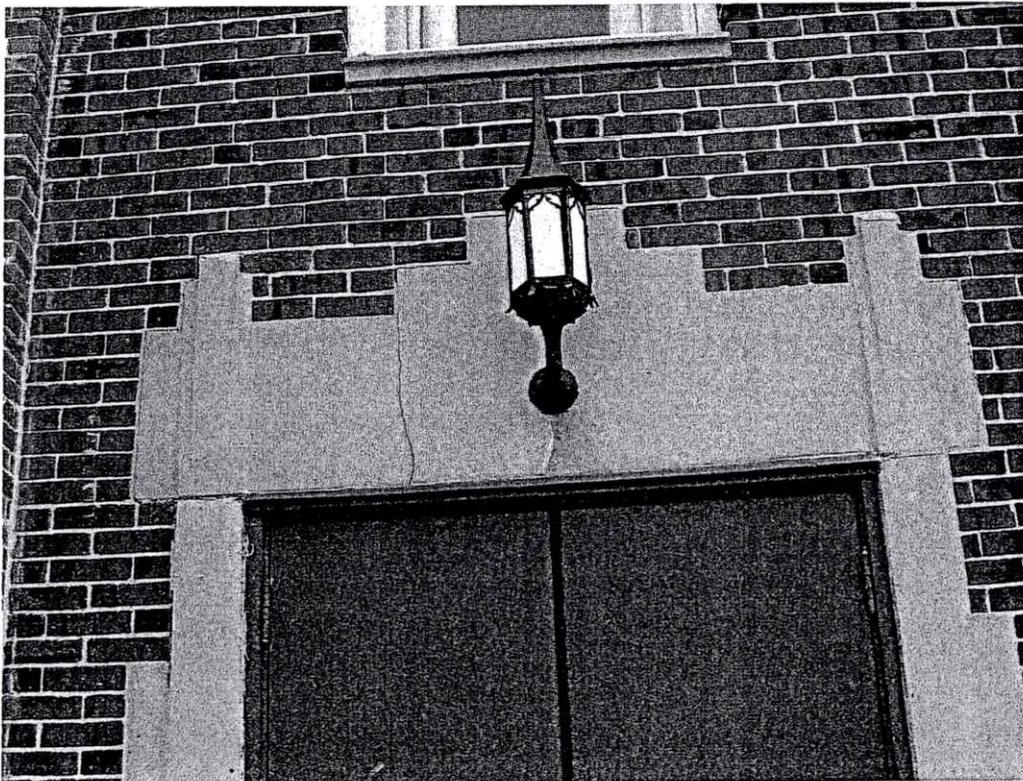
PHOTO 12 - Cracked precast concrete above the west elevation entrance door

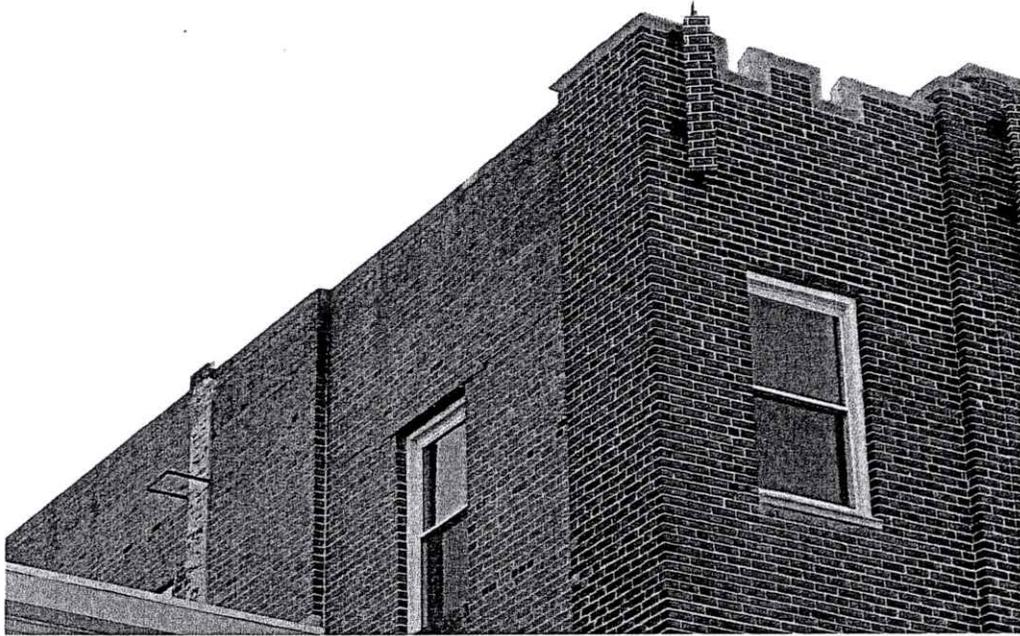
PHOTO 13 - Corner of the north elevation with mortar residue from the previous chimney

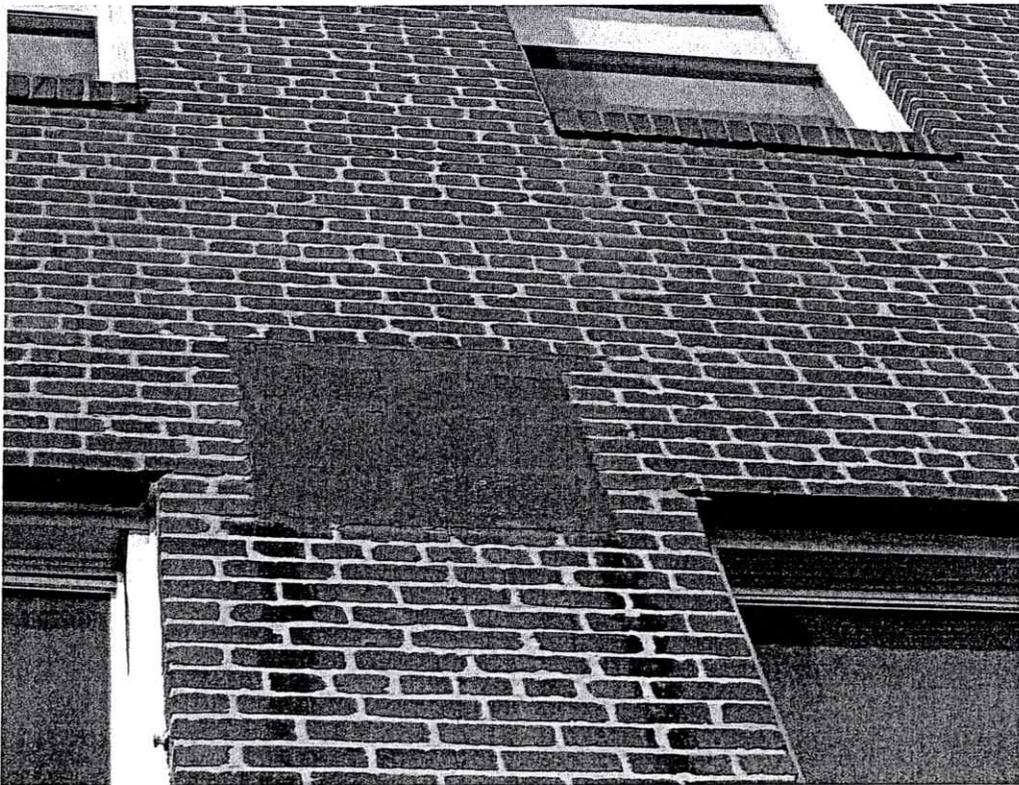
PHOTO 14 - Concrete block infill within the brick masonry wall of the east elevation
